Local Road Dilapidation Report City of Canterbury

Project Name: WestConnex New M5

Project number:	15.7020.2597
Document number:	M5N-CN-RPT-PWD-0001
Revision date:	09/05/2016
Revision:	00

Pre-Construction Road Condition
Report for WestConnex New M5 Main
Works Project – City of Canterbury

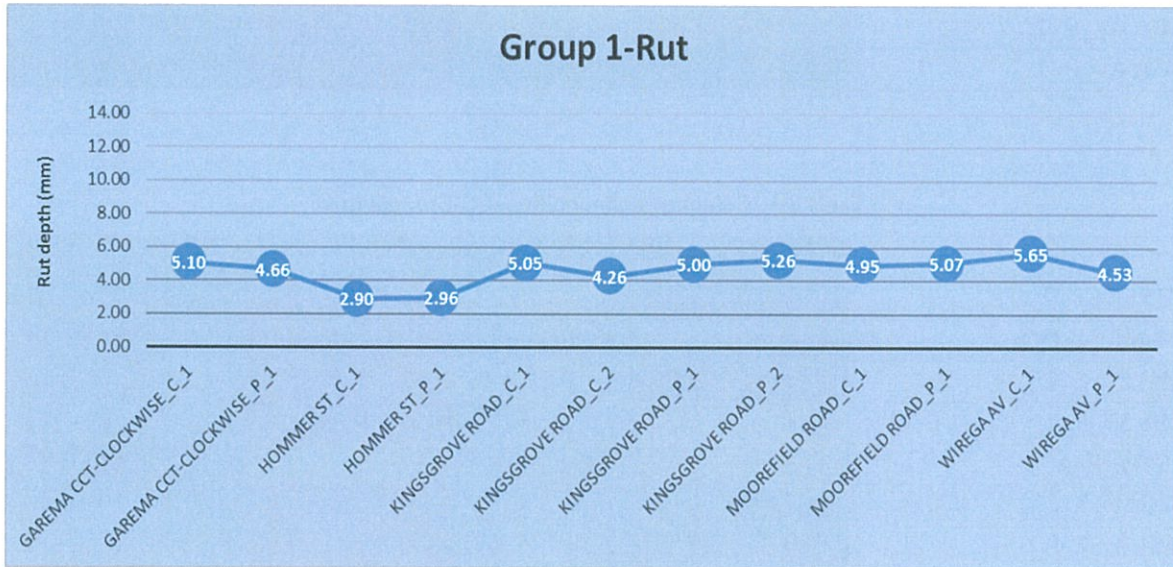
Figure 2.1: Rutting condition- CC-Group 1 road

Figure 2.1 and Figure 2.2 present the average rutting of each road direction/lane for Group 1 and 2 road sections. The majority of the sections in Group 1 present rut depth of about 5mm, which is 'good' generally. Group 2 roads show similar condition except Karingal Street which is in 'very good' condition.

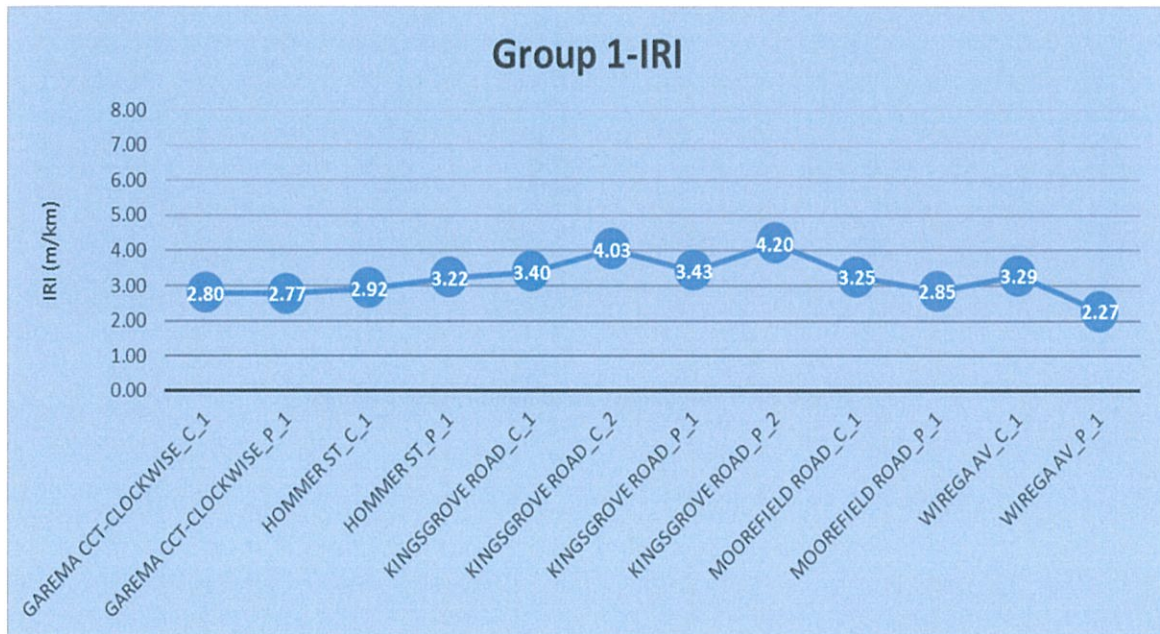
Figure 2.3: Roughness condition-CC-Group 1 road

Figure 2.3 and Figure 2.4 show the average roughness condition of each survey section per direction per lane for Group 1 and Group 2 road. Most roads in Group 1 present roughness value of less than 3 IRI with Kingsgrove Road showing slightly higher roughness. Armitree Street and Glamis Street in counter direction show high roughness value of nearly 6 IRI. Both directions of Poole Street present 'poor' roughness condition according to the definition (Section 1.3). Other roads in Group 2 show good roughness condition (mostly around 2 IRI).

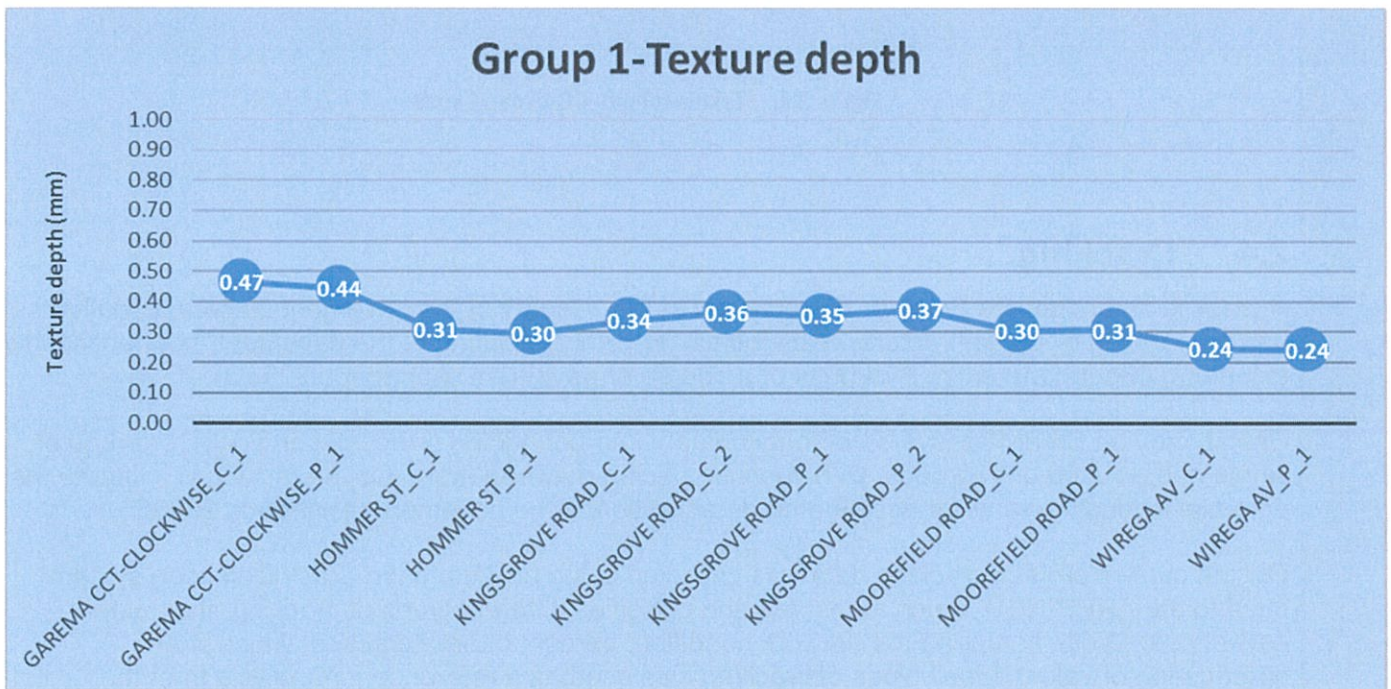
Figure 2.5: Texture depth- CC-Group 1 road

As indicated in Figure 2.5 and Figure 2.6 , most roads in Group 1 present texture depth of less than 0.4mm while Wirega Avenue has less than 0.25mm texture depth. Similar texture condition is found in Group 2 road.

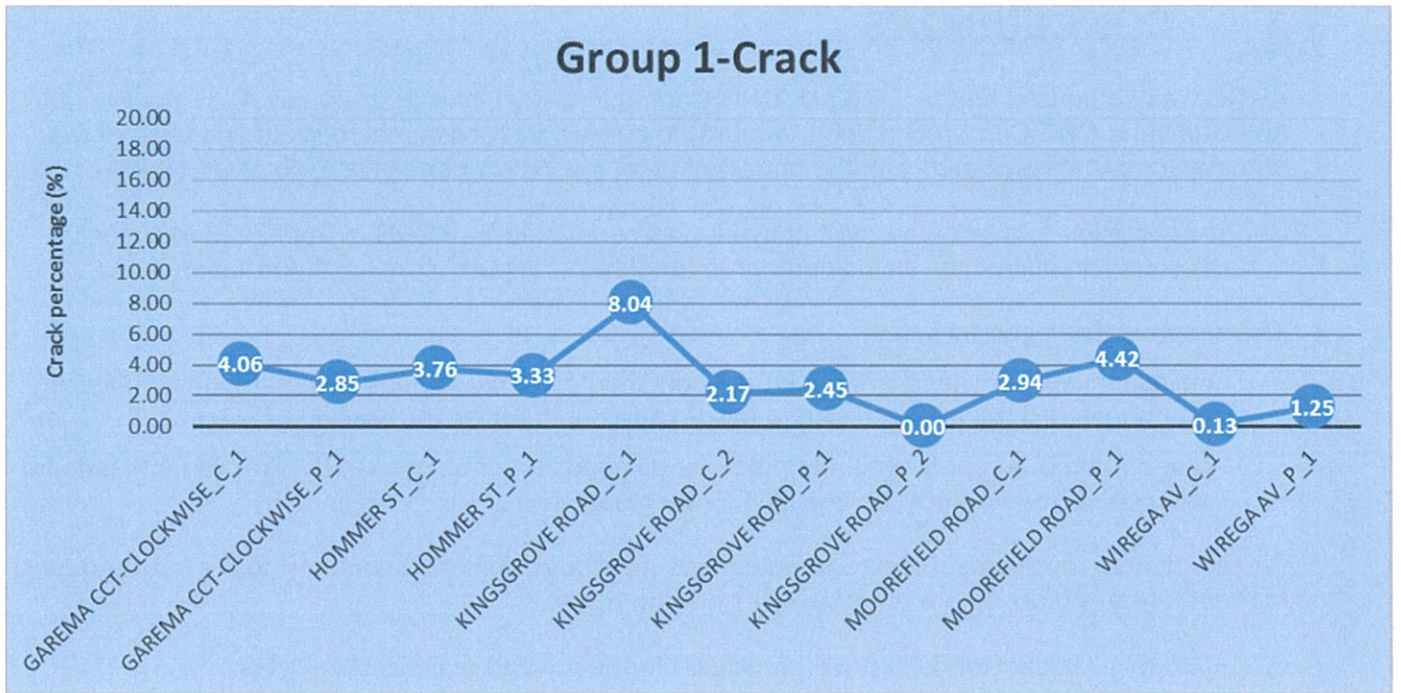
Figure 2.7: Cracking condition-CC-Group 1 road

Figure 2.7 and Figure 2.8 show the average cracking condition for both Group 1 and Group 2. Garema CCT both directions present larger than 10% localised cracking. Kingsgrove Road counter direction lane 1 is showing severe cracking of 22% cracked area. Moorefield Road is also heavily cracked with larger than 13% of localised cracked area.
