# ARBORICULTURAL REPORT

Kingsgrove Surface Works

WestConnex New M5

CDS-JV Document Number: M5N-ES-RPT-WSW-0006

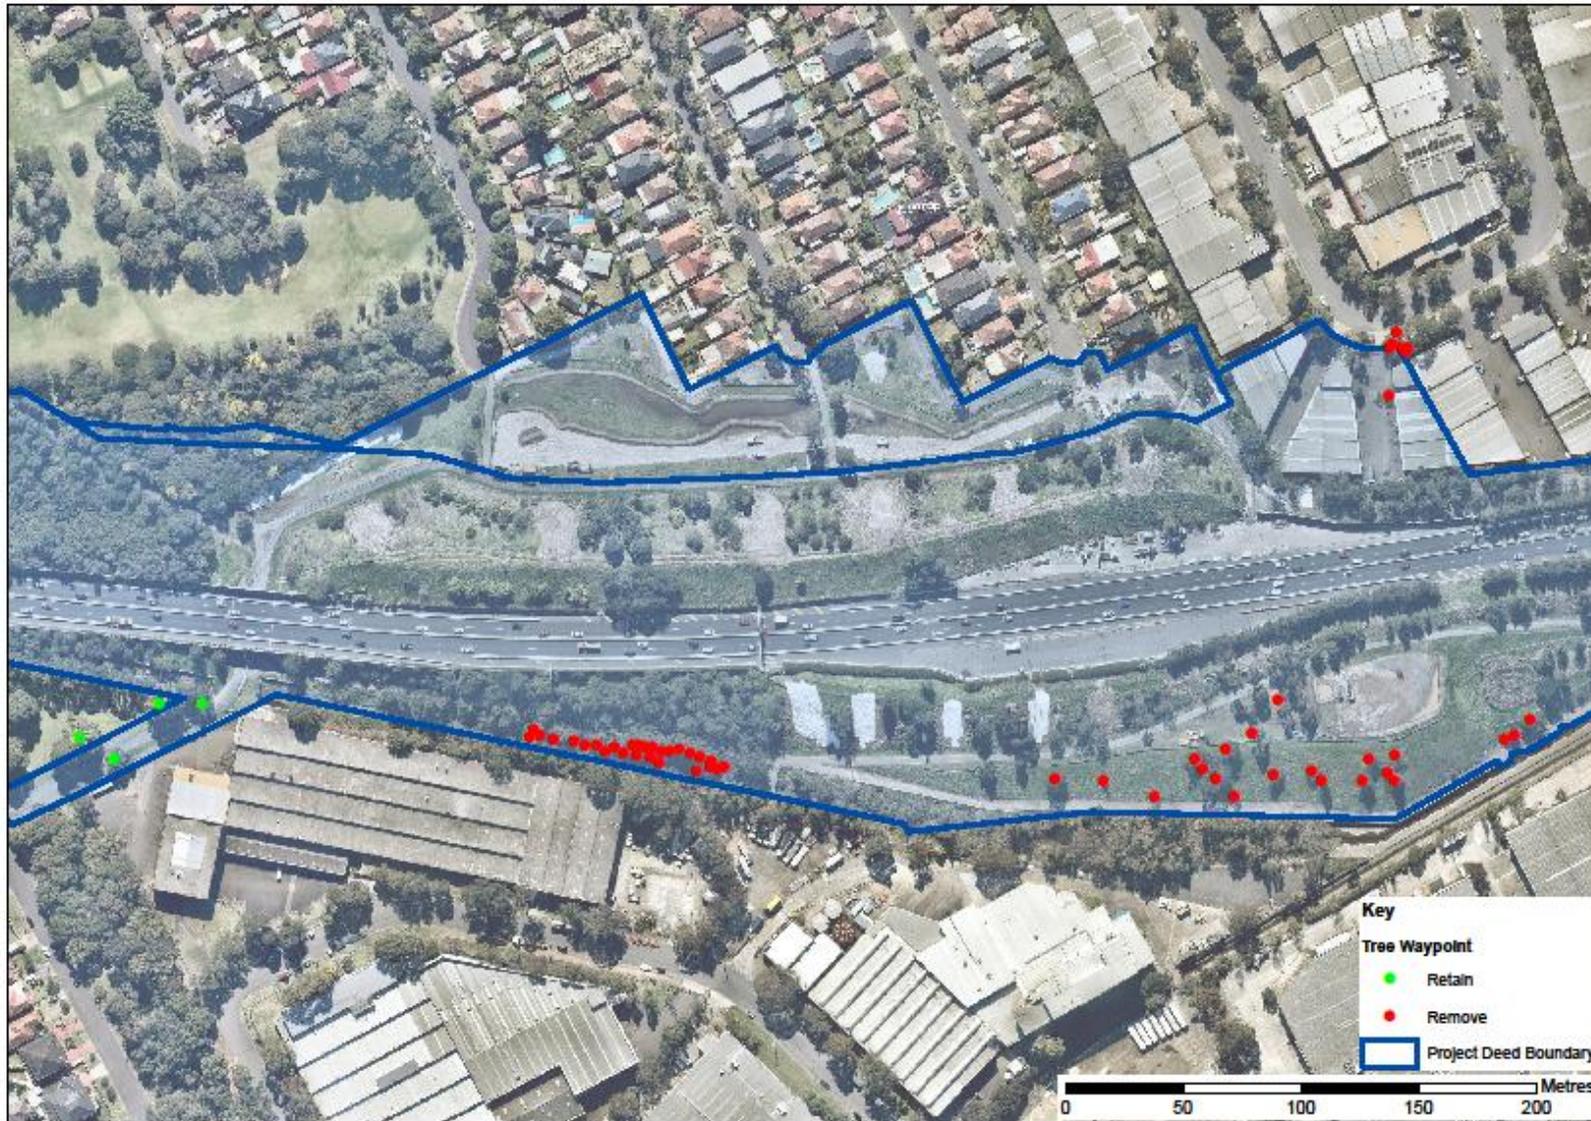
- Trees 1 – 7 Installation of shared pedestrian path and tunnel Support infrastructure (Map 3).
- Trees 8 – 34 Storm water under-boring (Map 4).
- Trees 35 – 55 Motorway complex (Map 5).

**Map 3.** Location of trees to be removed red dot. Green dot trees retention/ or removal of trees under consideration.

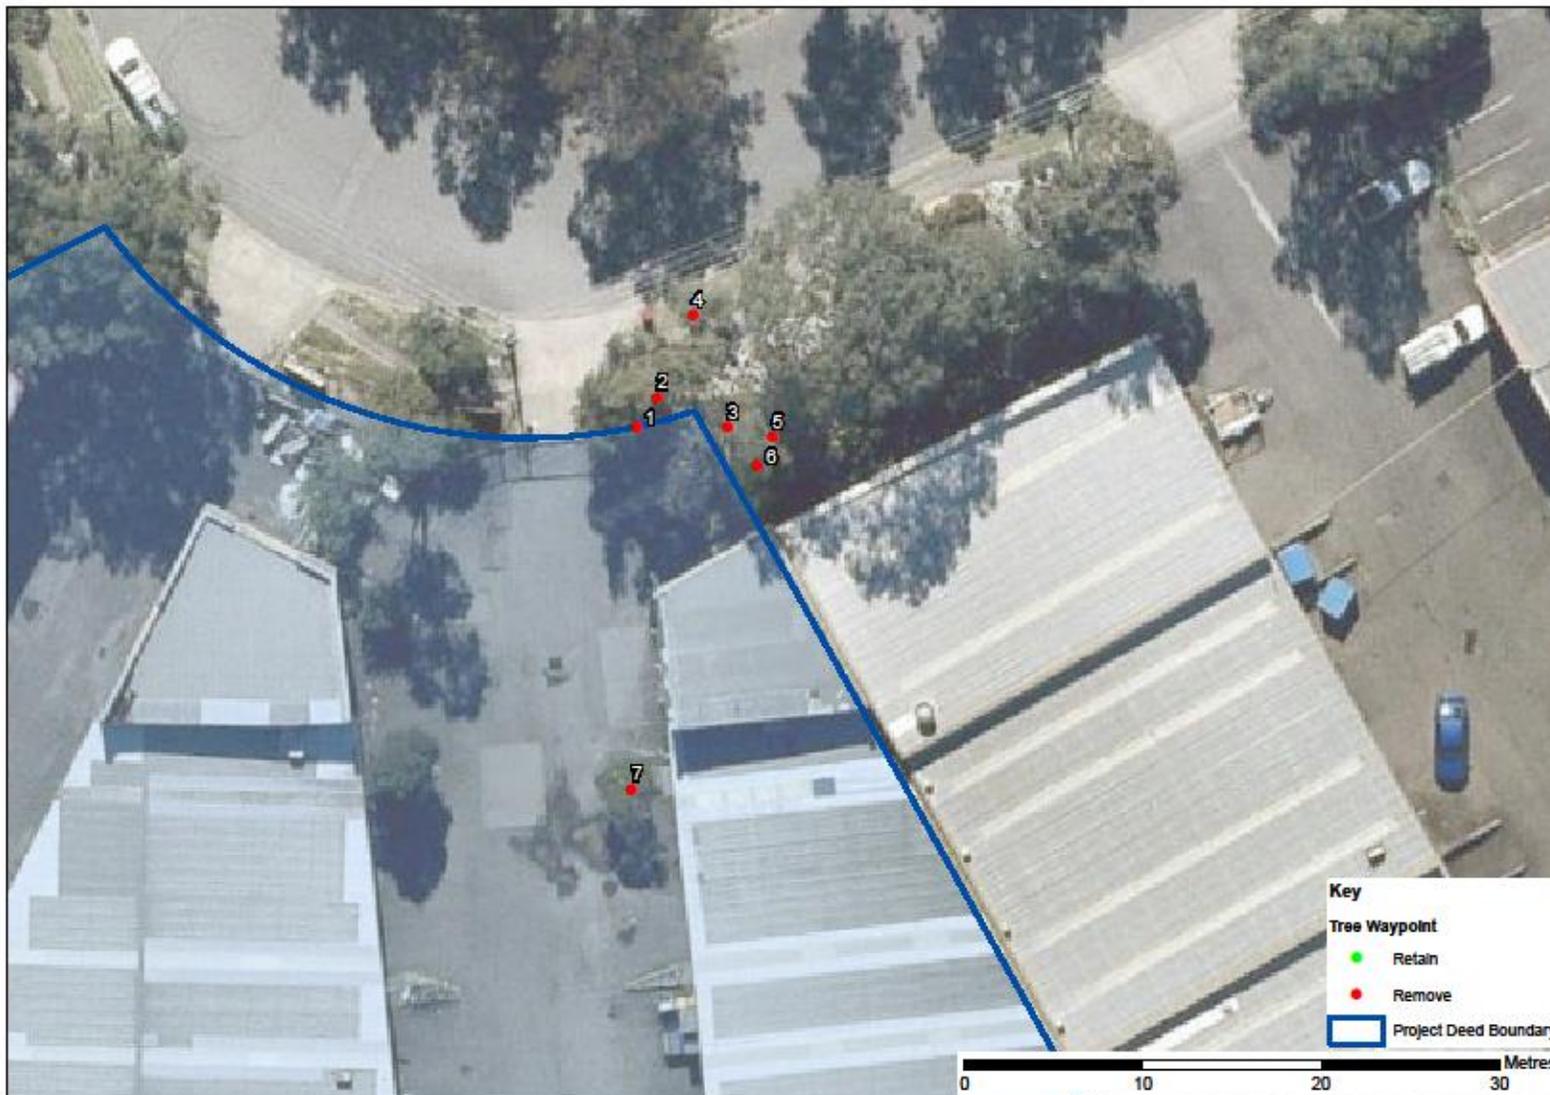
**Map 4.** Trees proposed for removal from tunnelling site.

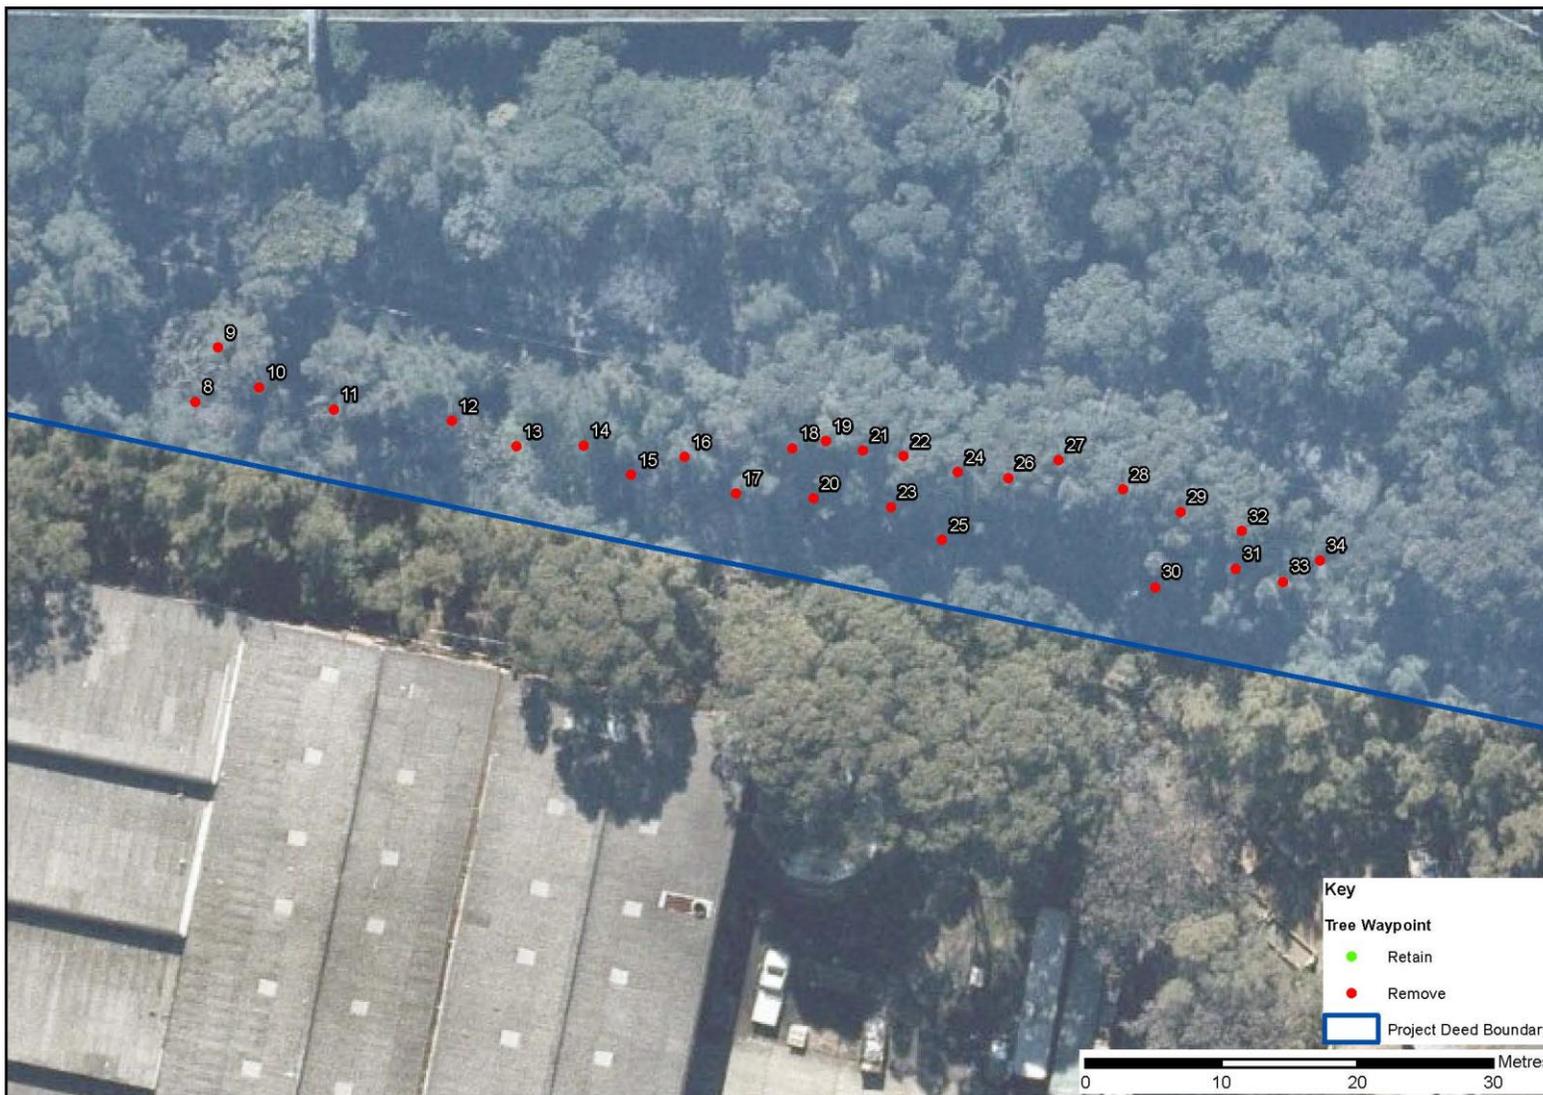
**Map 5.** Trees to be removed from storm water under boring site.

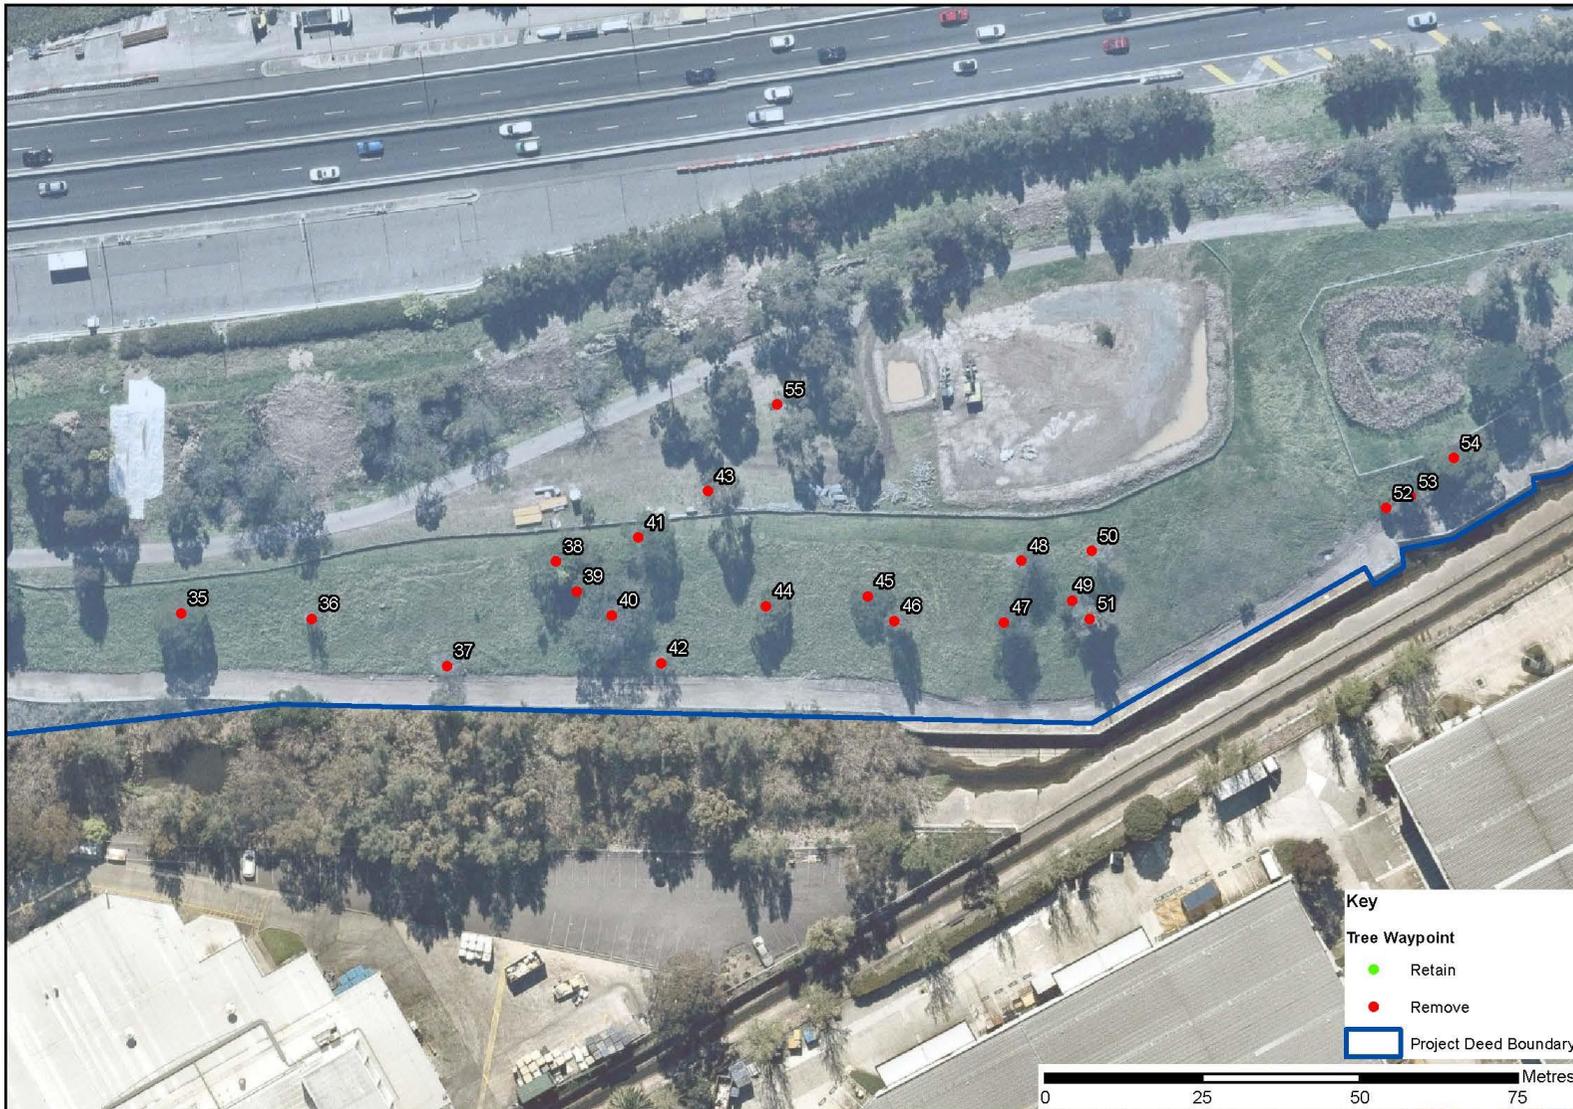
**Map 6.** Trees to be removed from Motorway complex.

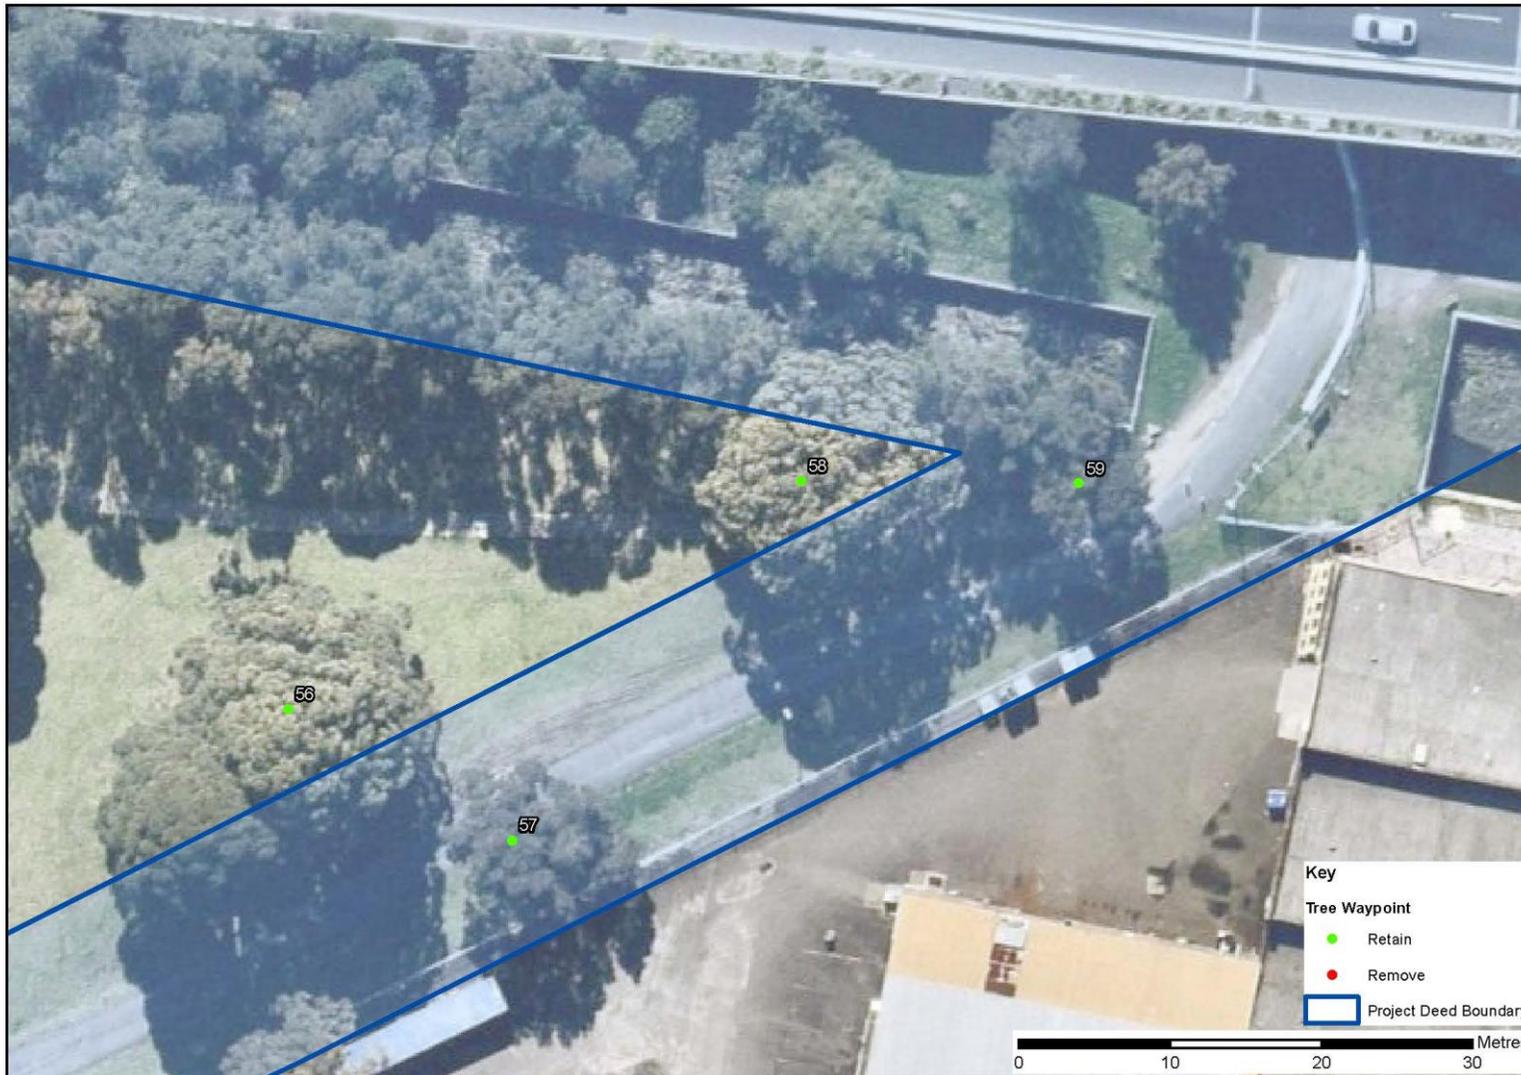
- Trees 56 – 59 Final decision still to be decided for trees in Tullawalla Pedestrian Path (Map 6).

**Map 7.** Tullawalla pedestrian path. Final plans for this area and whether the trees can be retained or removed pending final plans.

The following tree protection measures will be required for trees suitable for retention currently is only trees No 56 – 59. If it is determined that trees No 56-59 cannot be retained then this section is not required.

- Tree protection fencing must be established around the perimeter of the TPZ. If the protective fencing requires temporary removal, trunk, branch and ground protection must be installed and must comply with *AS 4970-2009 - Protection of trees on development sites*.

- If temporary access for machinery is required within the TPZ, ground protection measures will be required. The purpose of ground protection is to prevent root damage and soil compaction within the TPZ. Ground protection may include a permeable membrane such as geotextile fabric beneath a layer of mulch, crushed rock or rumble boards.

- The area within the TPZ is to be mulched with material that complies with *AS 4454-2012, Composts, soil conditioners and mulches*, and should be maintained at a depth of 50 - 100 mm.
