Arboricultural Impact Assessment

CPB Dragados Samsung Joint Venture (CDS-JV)

CAMPBELL ROAD – BETWEEN EUSTON & BURROWS ROAD
ST PETERS NSW 2044

M5N-ES-RPT-LRW-0058

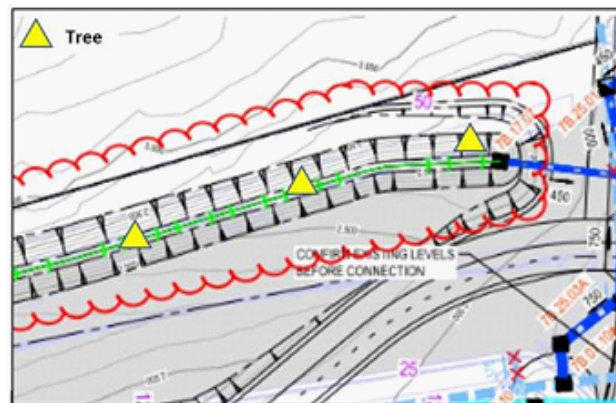
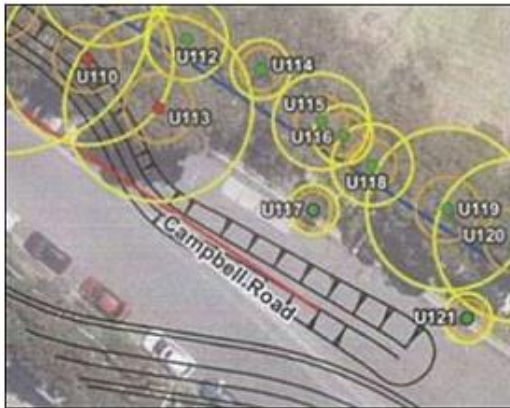
There has been an amendment in the location of the grassed channel, between the one provided in the tree report (early 2017), and the pre-IFC / IFC drainage drawings (2017/2018). The new design requires the removal of U113, U117, and U121.

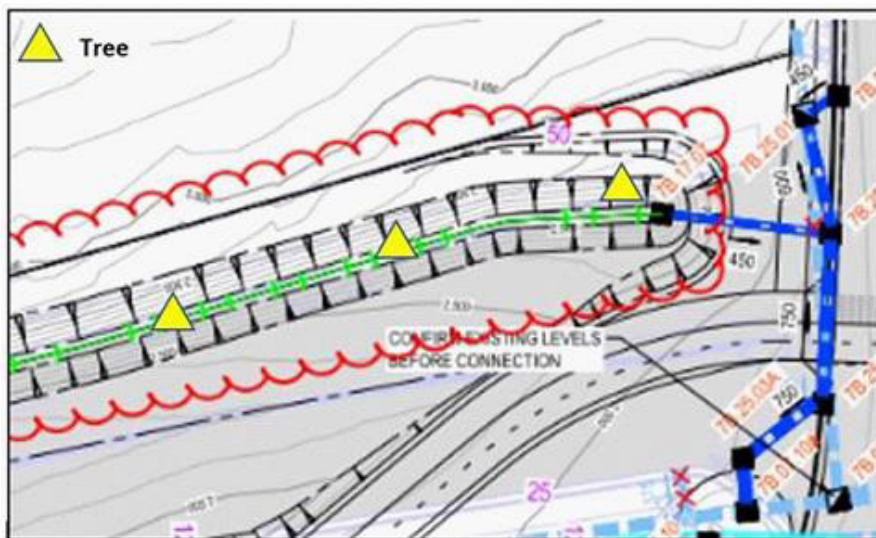
The tree report was prepared on 20 April 2017.
The latest design drawing M5N-AJV-DWG-700-300-DR-7110 (attached) was prepared on 12 January 2018.

The latest drawing shows the trapezoidal channel running in a relatively straight line, whilst the tree report shows it deviating.
As such, the latest design requires U113, U117, U121 to be removed.

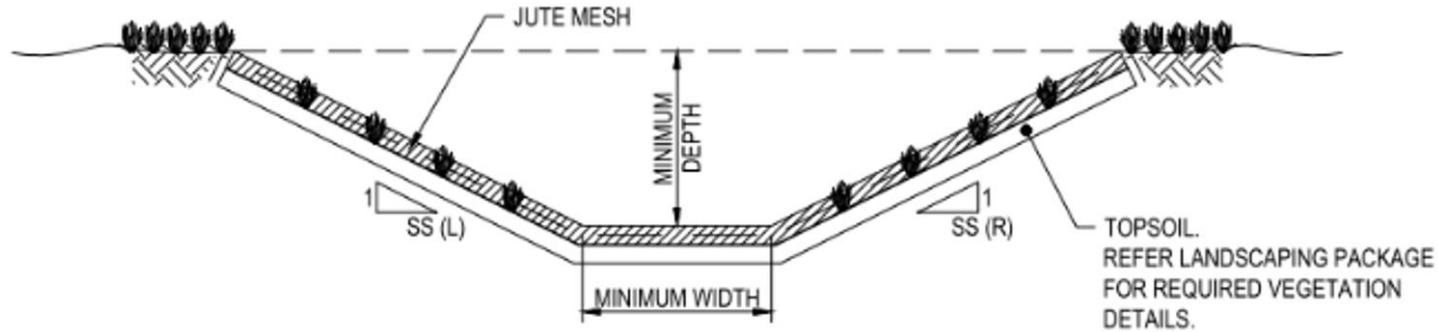
TRAPEZOIDAL CHANNEL GRASS / VEGETATED LINED
N.T.S.

CHANNEL LOCATION/ MX STRING NAME				CHANNEL SIZE TABLE (Approx.)				LINING / SCOUR PROTECTION			
Number	Location	Type	MX Model String Name	Width Minimum (m)	Minimum Depth (m)	Approx. Side Slope (SSL-SSR) Package reference	Channel Length (m) approx.	Type	Approximate Length (m) Chainage (m)	Comment	D50
7B.SW05	CAMPBELL ROAD - BETWEEN EUSTON ROAD AND BURROWS ROAD (NORTH)	TRAPEZOIDAL	IE37 & ID37	5.0	0.500	REFER MODEL	134	GRASS LINED	118		N/A

- The proposed drainage swale has been estimated as a 12.1m² encroachment, equating to 8.8% of the TPZ (see Figure 1 below and Appendix K for Cross section detail). This is considered minor encroachment under AS4970 and detrimental effect on tree health or condition is not expected.

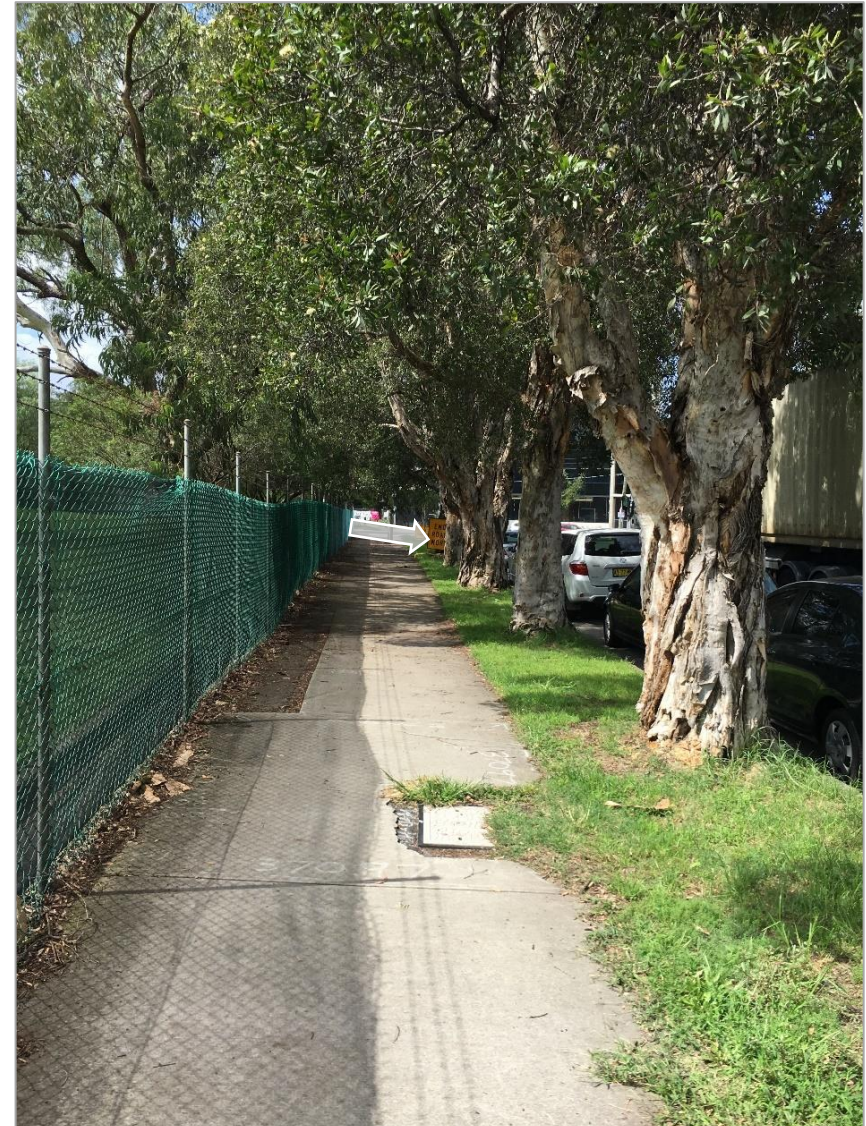
Plate 5 – U113 noted with arrow. Rest of trees in row has been removed with approval.
