# Arboricultural Impact Assessment

Westconnex New M5  
Traffic Intersection  
Bourke Rd, MASCOT

*CDS reference: M5N-ES-RPT-LRW-0042*

**VERSION 3**

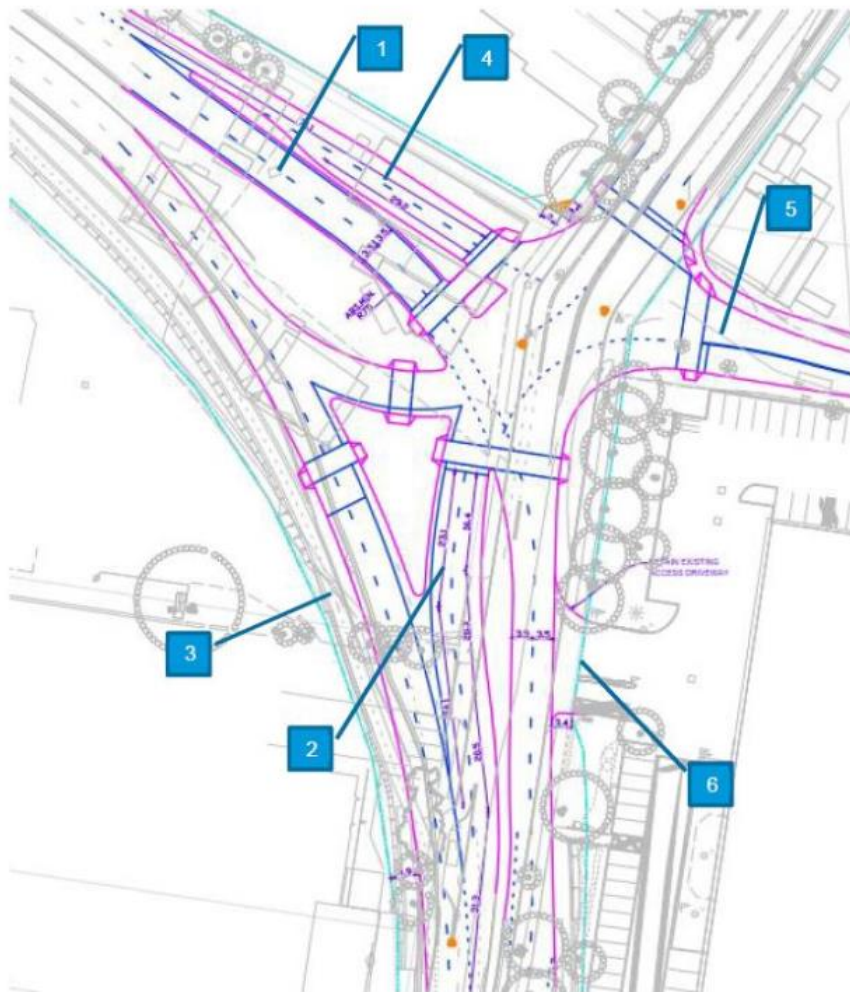
**Figure 2-1 Proposed Campbell Road extension / Bourke Road intersection design**

1. Two through lane southbound lanes on the Campbell Street extension approach to the intersection
2. Provision of dual right turn lanes at the southern approach on Bourke Road. This involves modifications to the western and eastern kerbside of Bourke Road.
3. Redesign of separate cycle lane and pedestrian footpath to a shared path along Bourke Road to provide additional road space for the dual right turn lanes and two through lanes on Bourke Road northbound.
4. 'Slip lane' access southbound to the access easement off the Campbell Street extension and signalised.
5. Access easement signalised.
6. Left-in left-out access into 520-530 Gardeners Road.

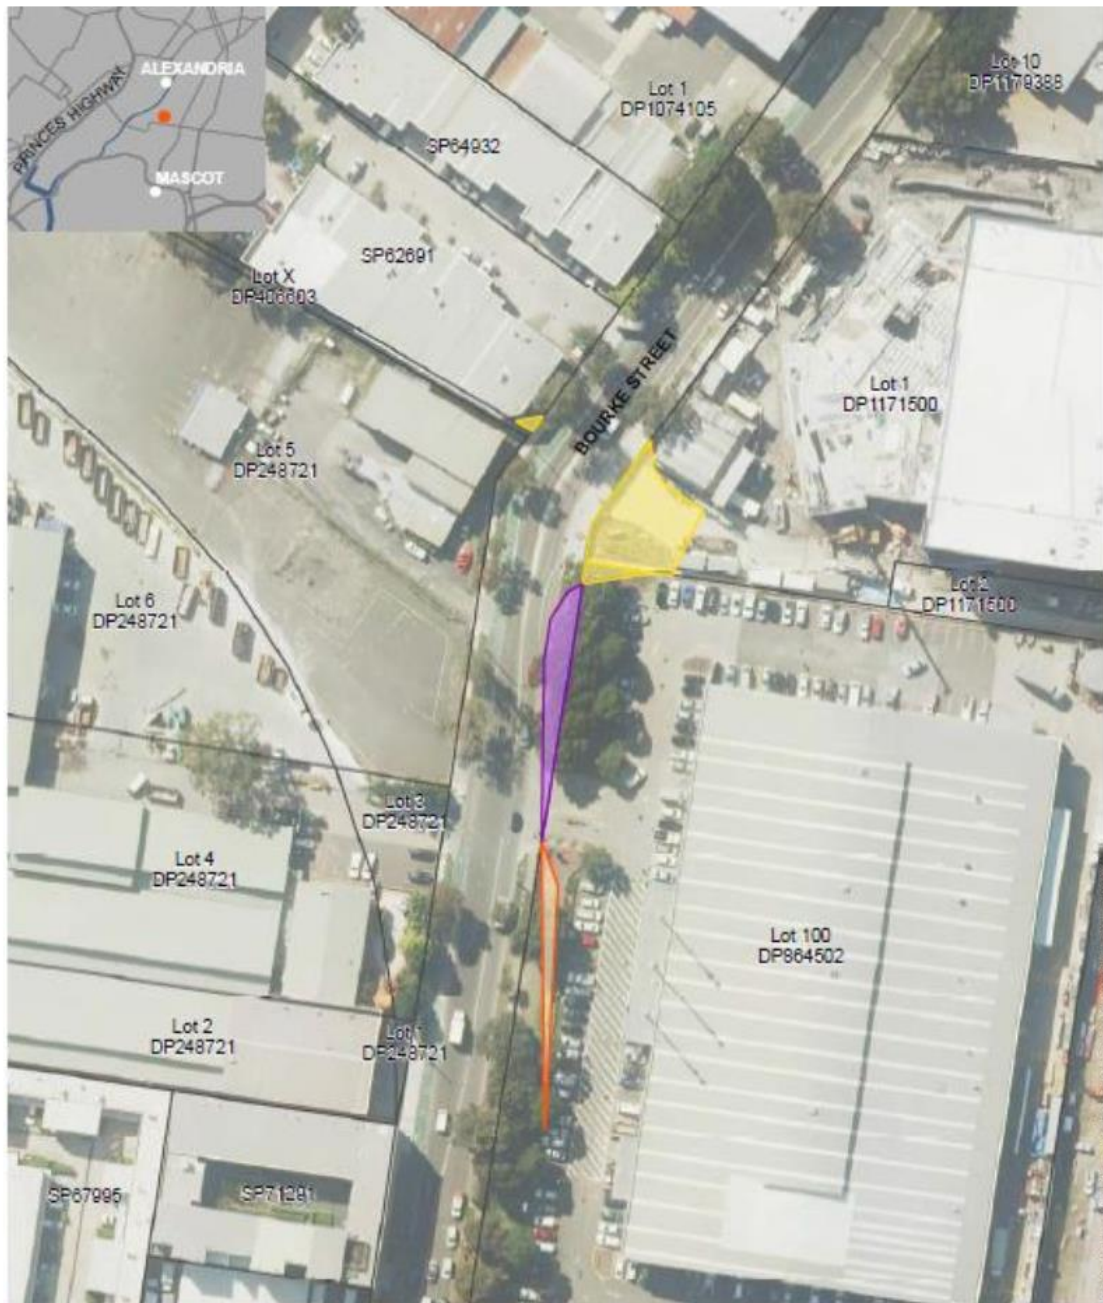
**Figure 2-2 Additional property acquisition requirements for the proposed Campbell Road extension / Bourke Road intersection design**

- 77-79 Bourke Road: 15 square metres
- 200 Bourke Road: 380 square metres
- 520-530 Gardeners Road: 30 square metres
- Bourke Road verge (City of Sydney Council): 165 square metres.

Access to 520-530 Gardeners Road from Bourke Road would remain as left-in and left-out only movements as per the Approved Project. In addition to the property acquisitions required for the Approved Project, the proposed design change would require the following acquisitions shown in Figure 2-2:

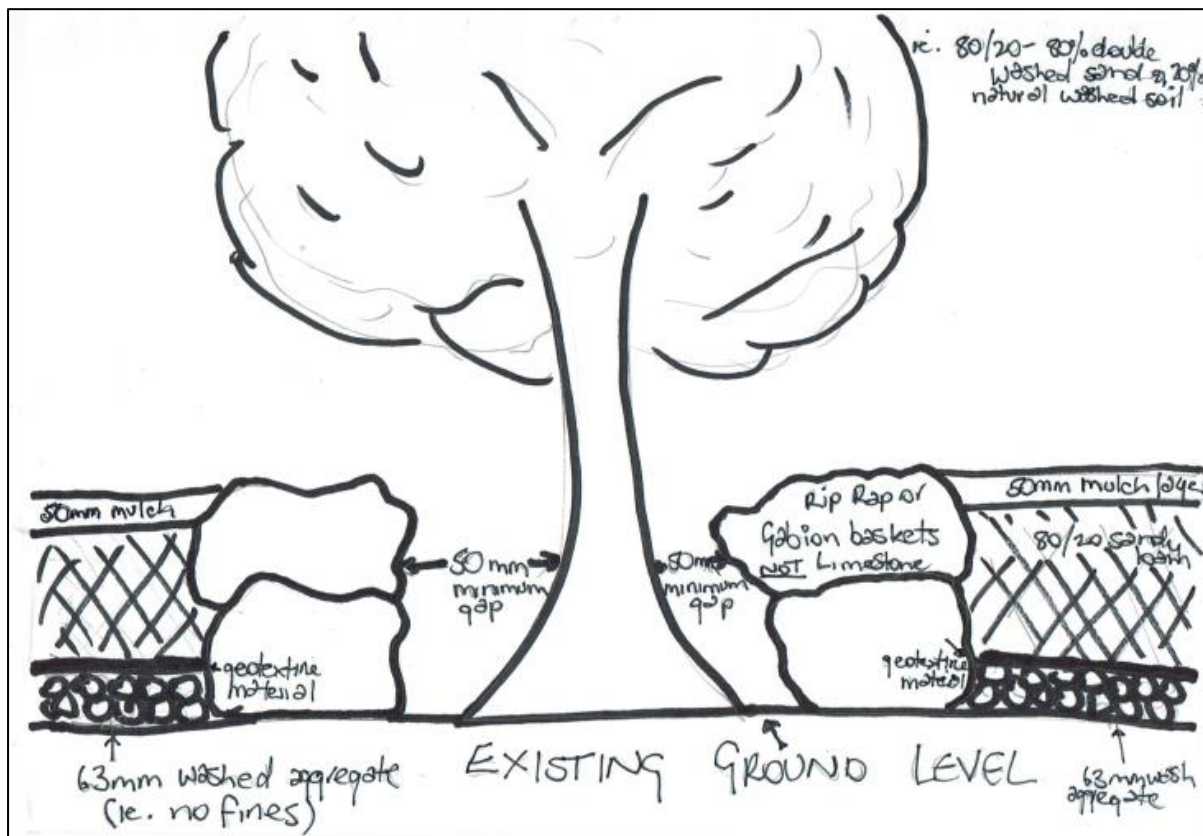
6.7 Appendix F - Specification for Fill around Trees to be Retained

**NOTE** – The 50mm gap between the fill and the tree stem is to be from the base of the stem – the widest part of the stem.

Fill is proposed to the west of the tree stem in excess of 450mm in places, this will have a detrimental long-term impact should it not be carried out to allow continued adequate porosity and aeration to the roots below. Thus, strict adherence to the specifications set out in Appendix F and within the Recommendations - Section 3.2.5 of this report is required.

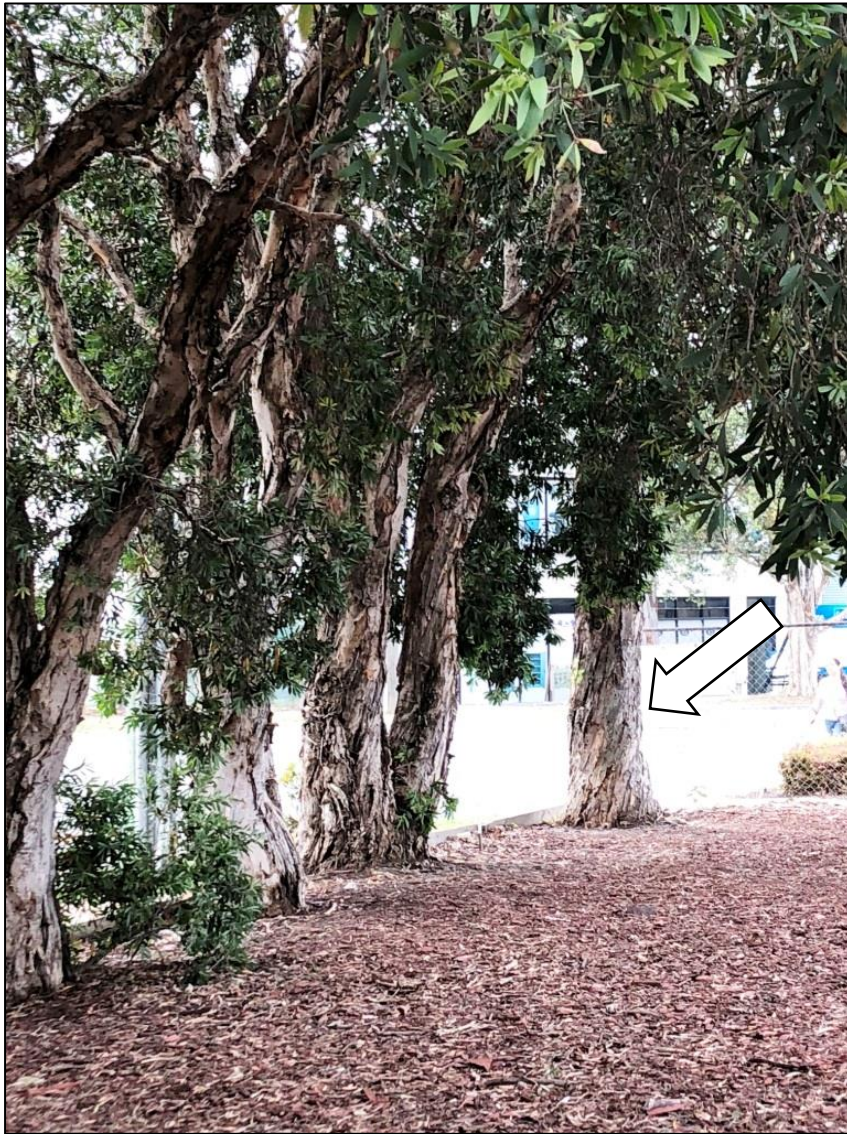
Plate 1 – Arrow notes T5 that requires removal due to proposed ground level reduction within the SRZ to the east of the tree stem.

Four (4) trees require removal to accommodate the proposed works (T5, T13, T16 and T17). Replanting will be undertaken in accordance with the condition B63 of the Compliance Table.

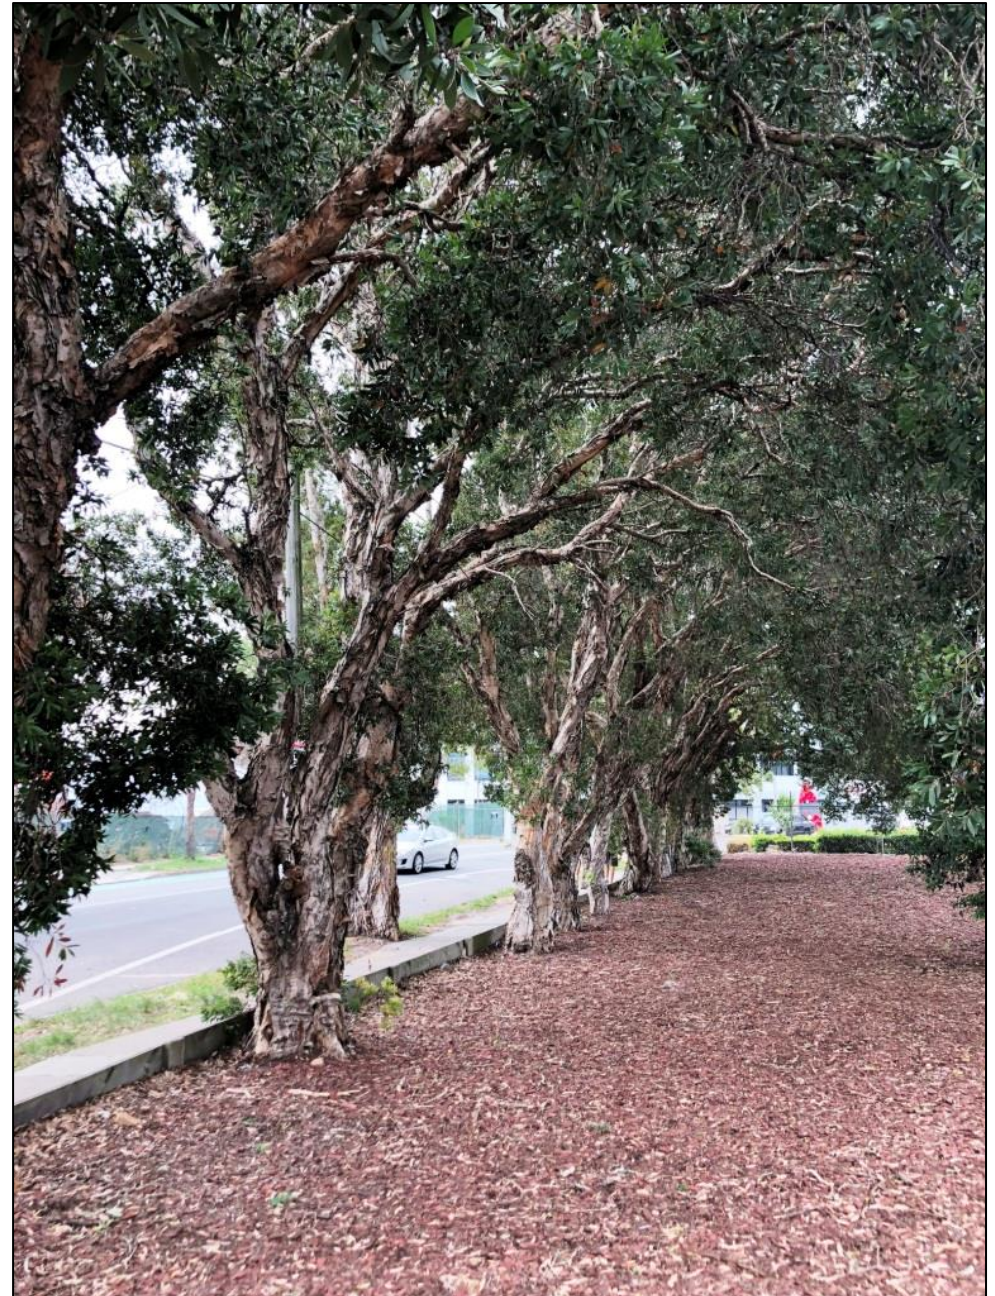
Plate 2 – Note the extensive unimpeded area to the east of the trees being retained that will remain unaffected and is likely to contain the majority of the healthy root systems.

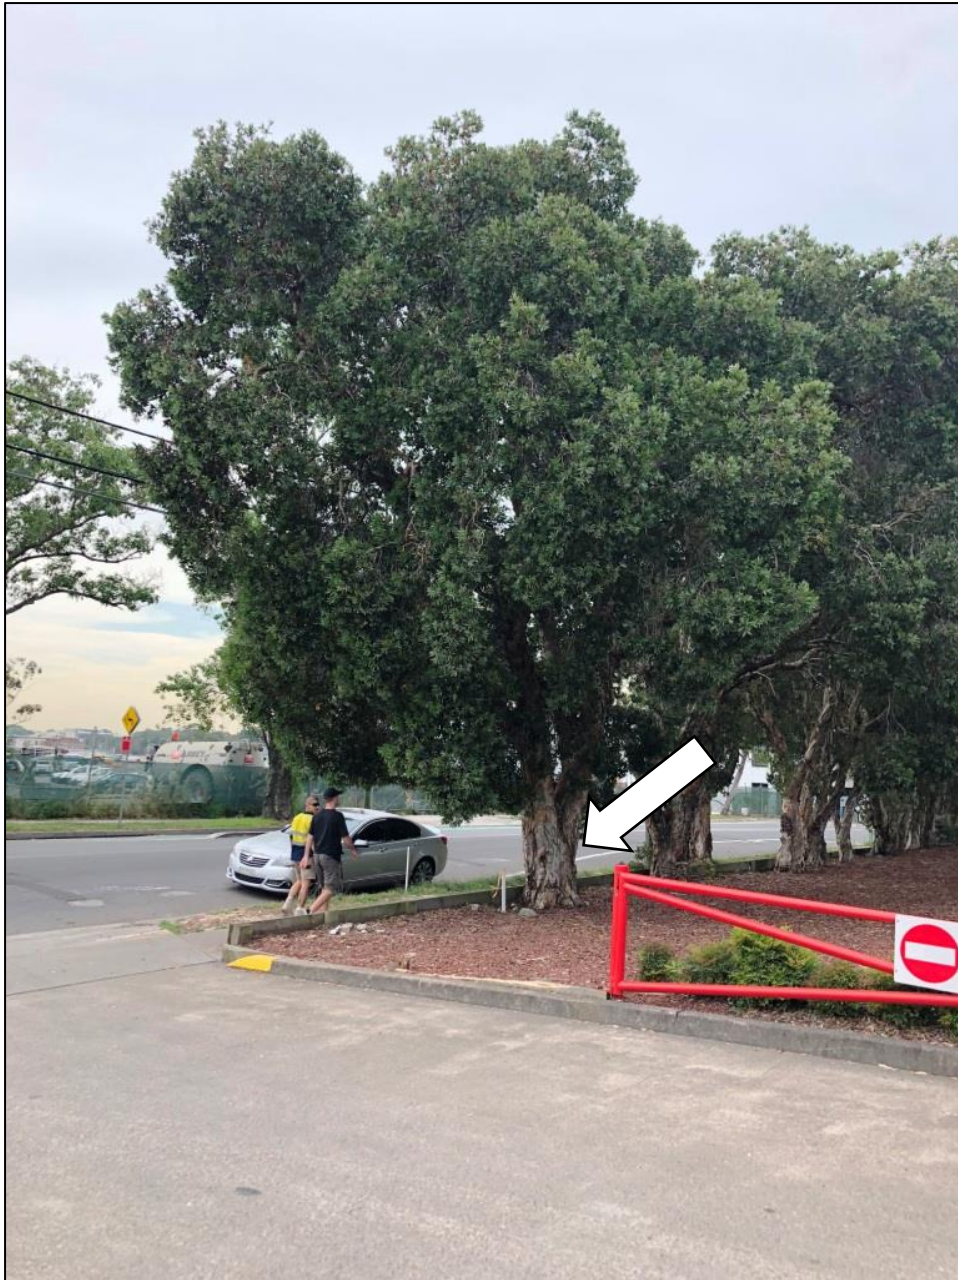
Plate 3 – Arrow notes T16 that requires removal due to proposed ground level reduction within the SRZ to the east of the tree stem.

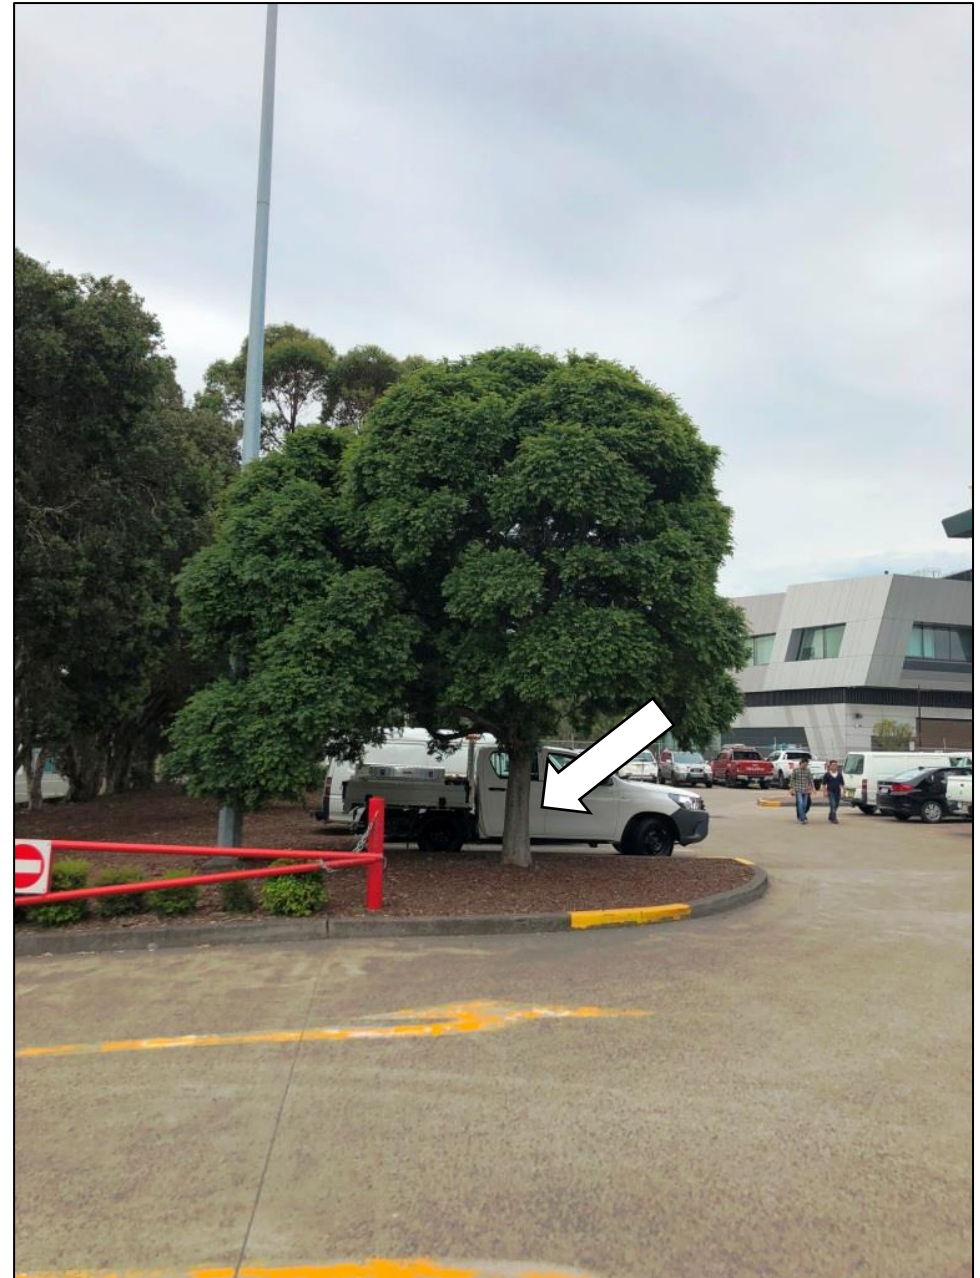
Plate 4 – Arrow notes T4. This tree can be retained.

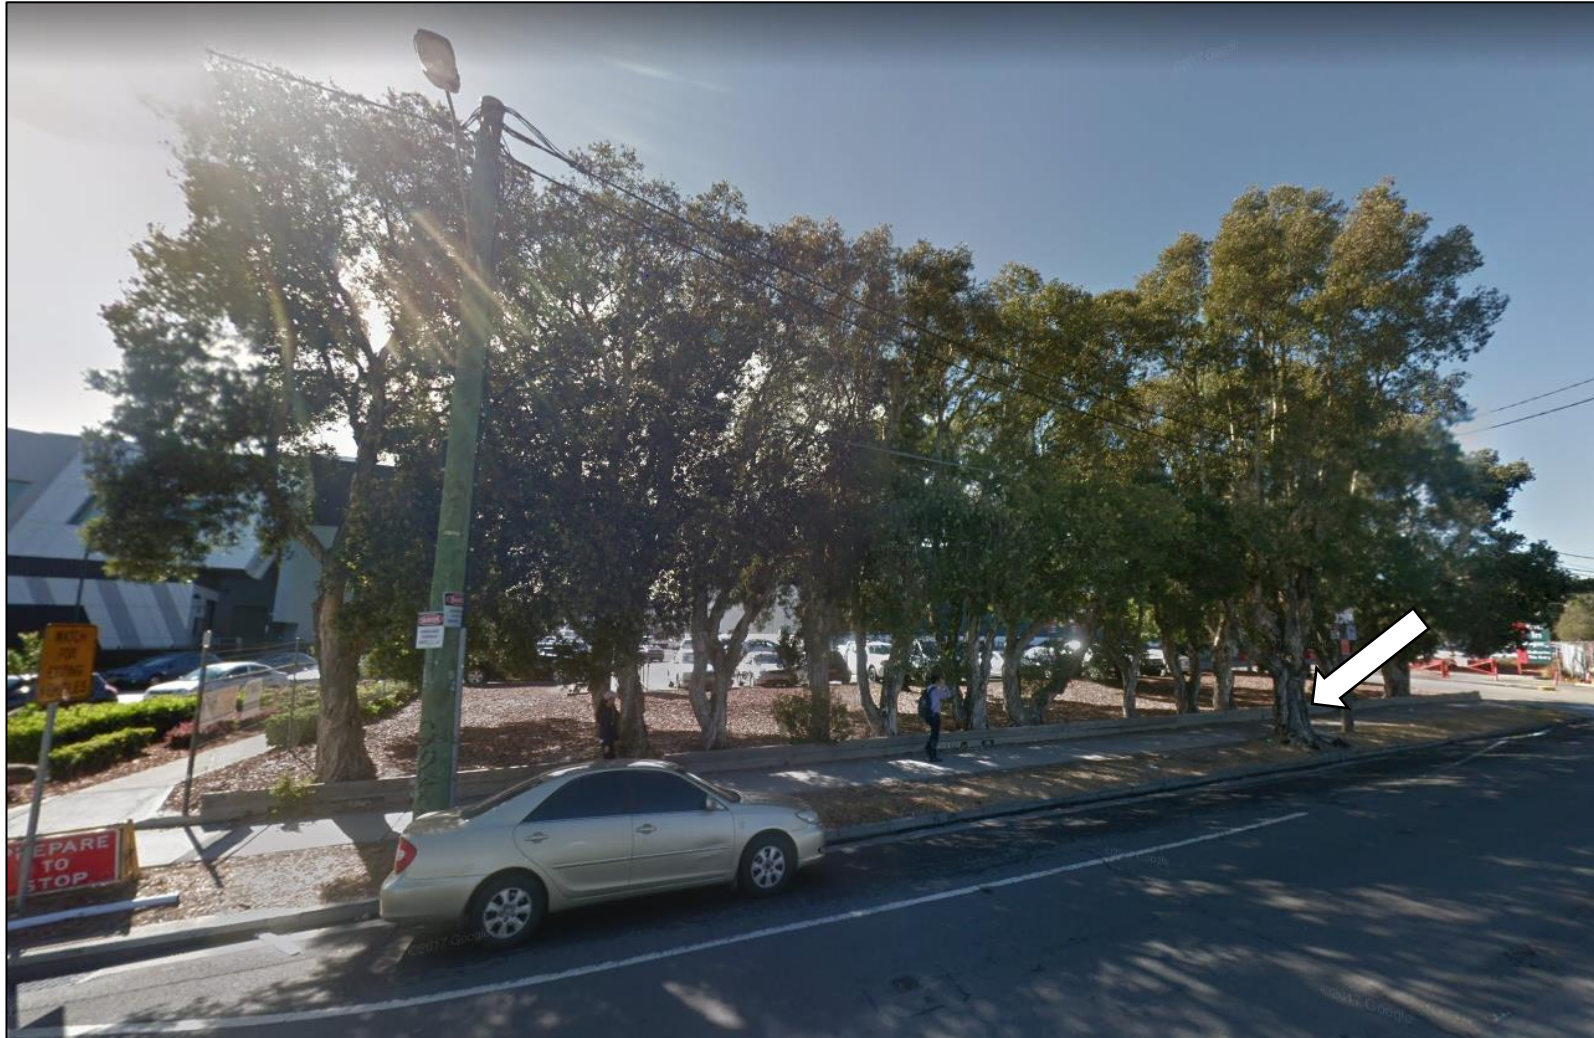
Plate 5 – Row of Broadleaved Paperbarks can be seen (T5-T17). Red arrow notes T17, located beside curb instead of within private property boundary. Photograph courtesy of Google maps street view. Marked up by [REDACTED] 20/8/2018.

level changes are unacceptable within the Tree Protection Zones (TPZ) of existing trees, lowering ground levels to the extent proposed will incur major root severance and render the trees unstable. Tree 17 is located within the benched swale and fill cannot be located hard against the stem without this tree eventually succumbing to root decay and failing.
