Arboricultural Impact Assessment

Westconnex New M5
Hoarding Realignment for MOC3
Marsh Street,

CDS reference: M5N-ES-RPT-ARN-0022

REVISION 4

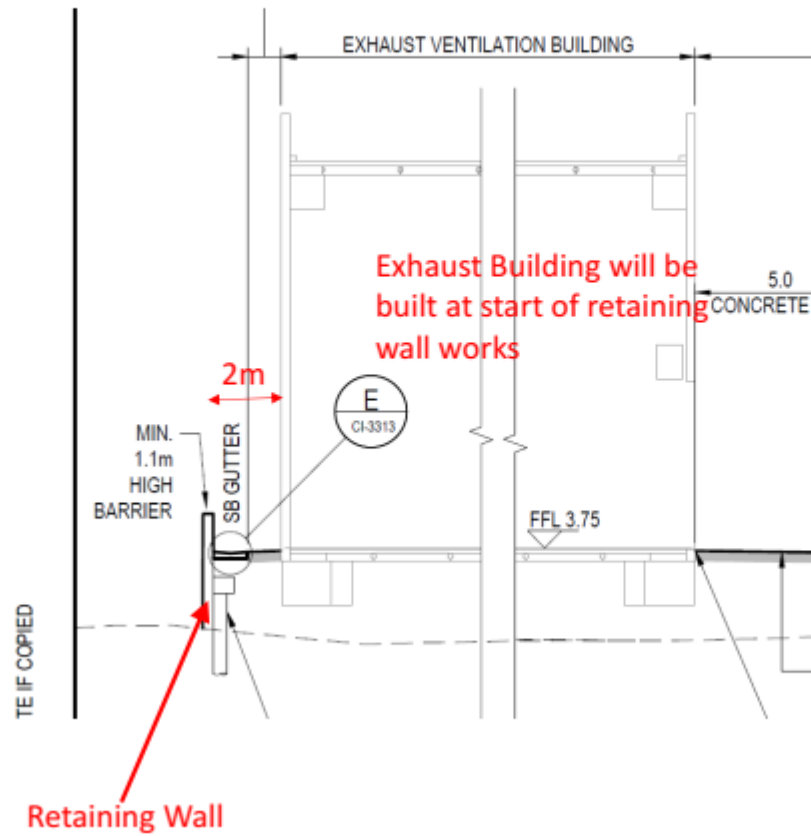
The last slide displays the space we have on the site side of the retaining wall (2m). This is the main reason that we cannot carry out works form inside the boundary. The plant will not fit. Due to this being a retaining wall the outside face will also require back filling and compaction to restore the ground to its original condition. This will involve an excavator and roller to work outside. This would be the case even if we had ample room on the inside.

Sections showing lack of space on site side of retaining wall

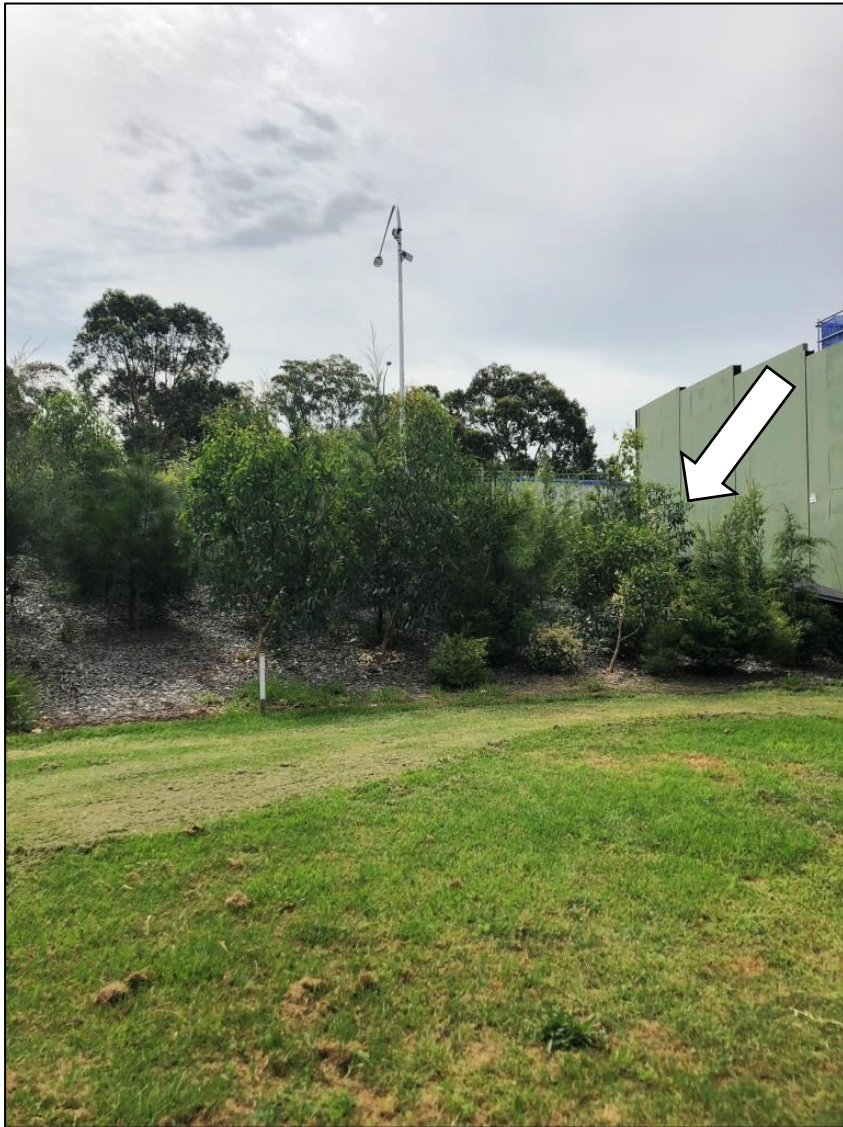
Plate 1 – Arrow notes G17 that require relocation or removal to accommodate realignment of Hoarding.

Part of Group 17 will require removal to accommodate the works. These are recent plantings and, if found practical, have the potential to be replanted back into the site post completion of the subject works (or adjacent to the site in existing gaps in the mass planting prior to the commencement of works).

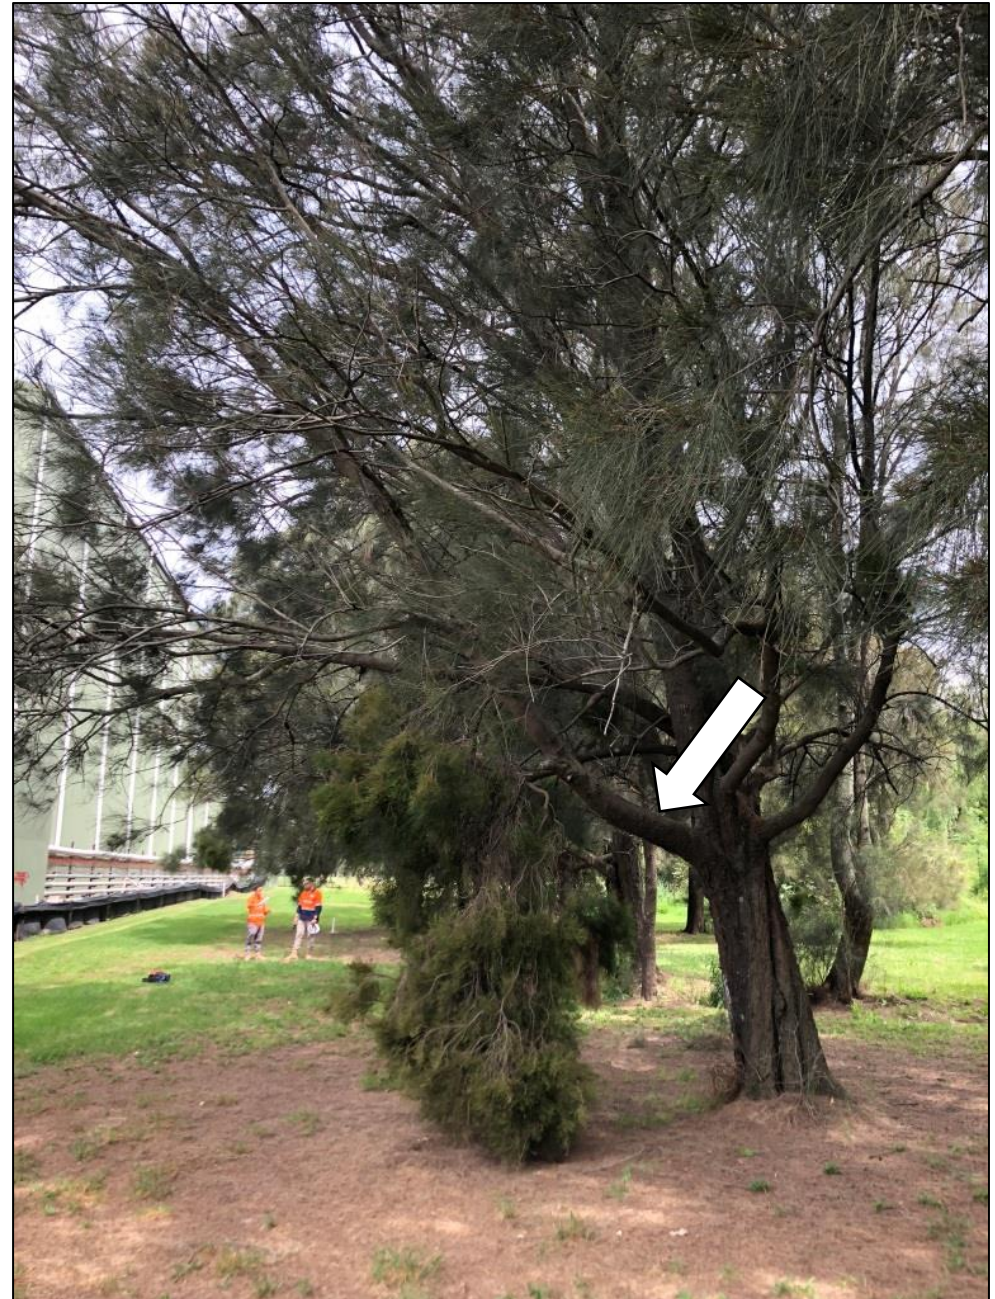
Plate 2 – T10 – tree will require heavy pruning with lowest approximately 250mm diameter pruned back to stem junction to accommodate works.

However, the tree will require heavy pruning to accommodate equipment and the hoarding positioning. Whilst this is far from ideal for tree vigour in the short term, the required pruning is of the lateral branches only. This will allow the branches to be cut cleanly at the stem/branch junction, given the tolerance of this species of disturbance (and readily suckering growth habit) and the optimal growing conditions in which the tree is located, it is my opinion that the tree will recover and produce ample epicormic growth to ensure ongoing longevity.

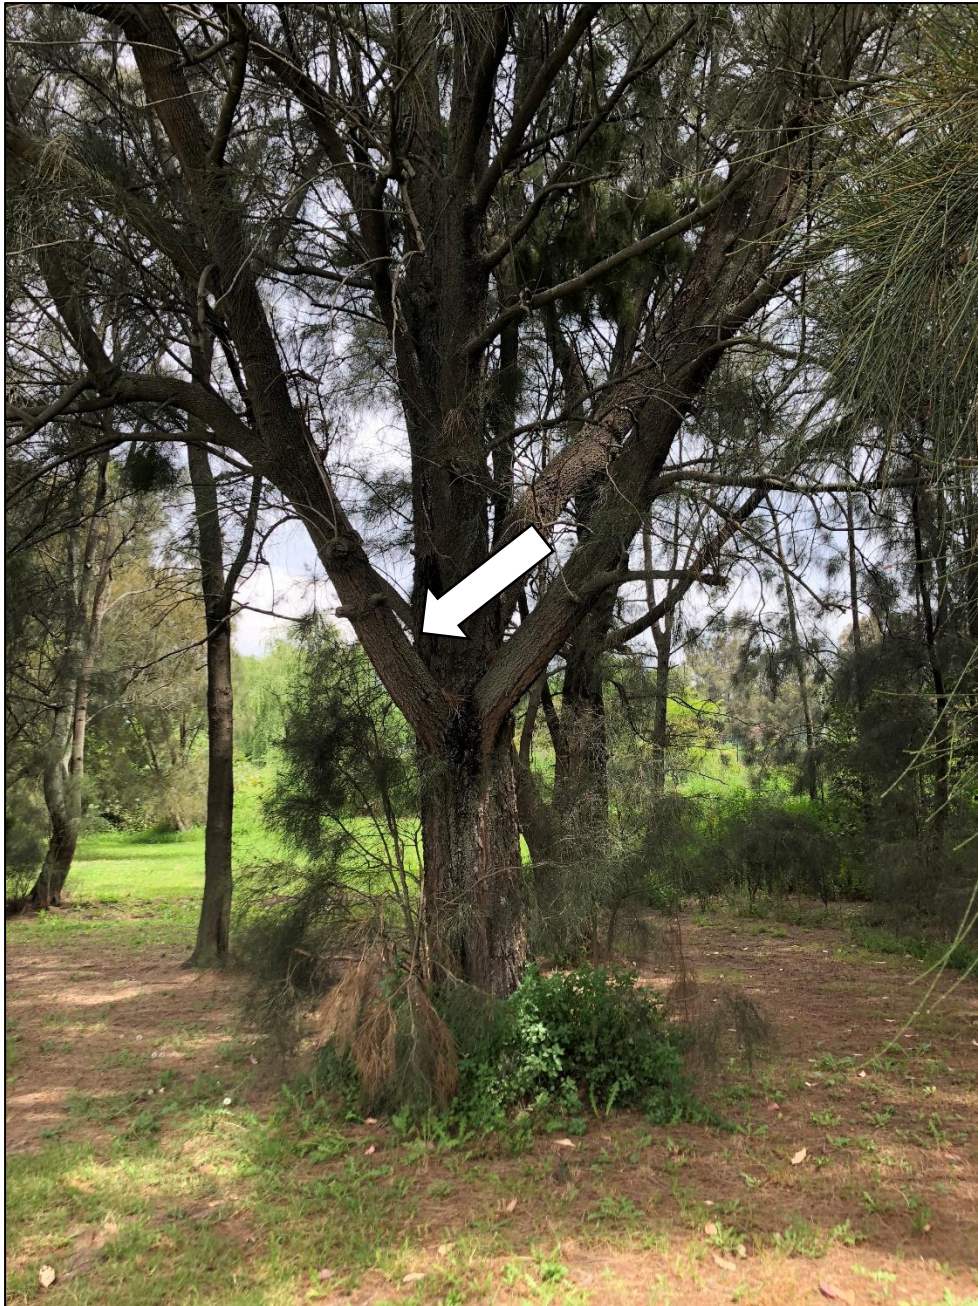
Plate 3 – Arrow notes to large diameter limb on T13 that requires removal to allow Hoarding realignment.

Short-term impacts are expected (epicormic growth, loss of vigour) and potential long-term impacts may occur (spread of decay into main stem, die-back of cambium). Given the tree is located within optimal site conditions and away from any but very rare pedestrian access, I believe retention of the tree is viable in this instance.

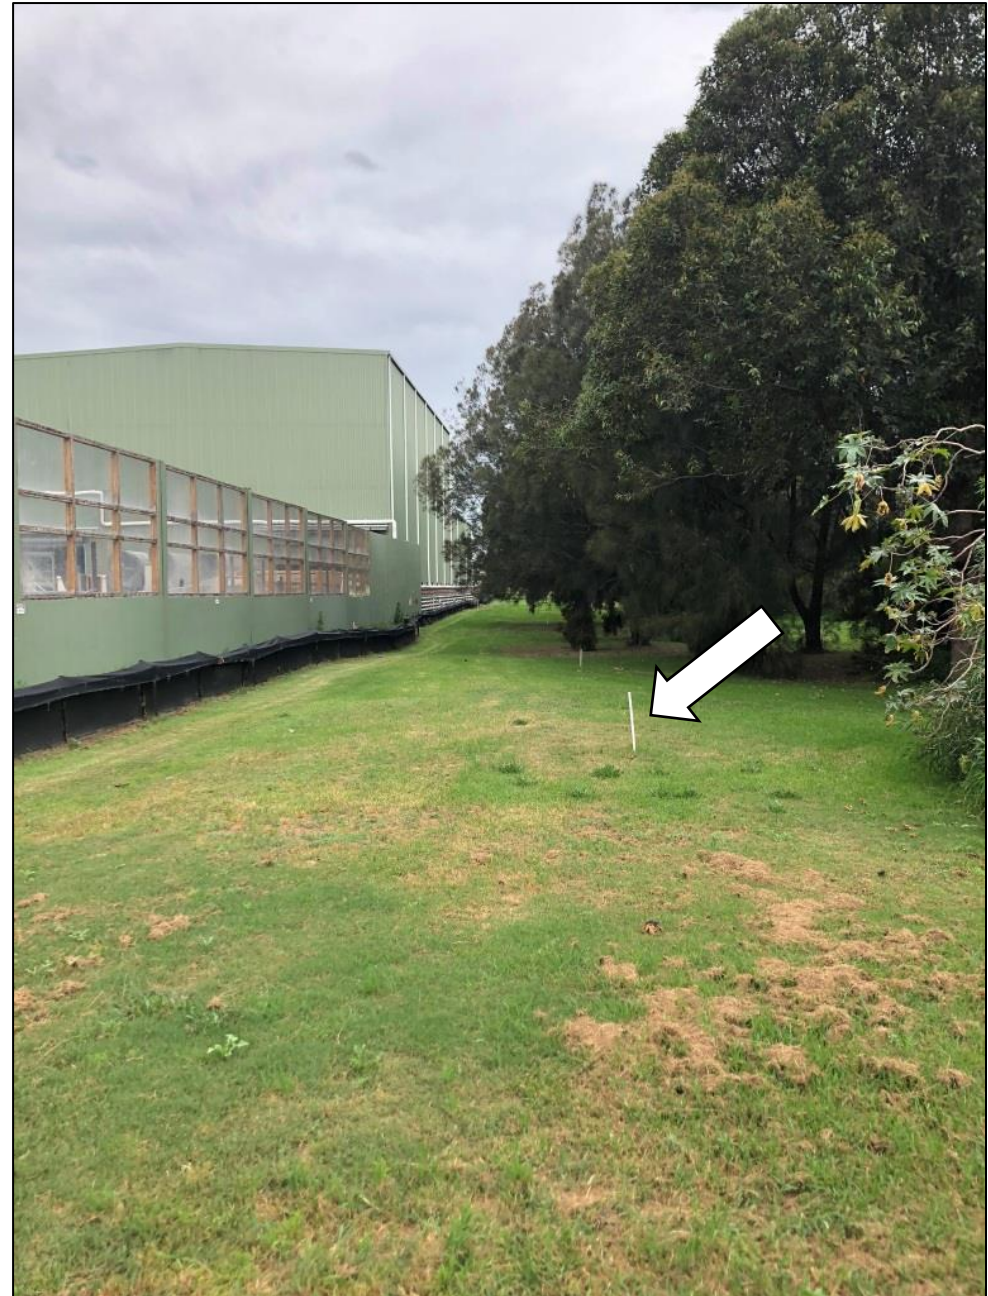
Plate 4 – Overview of site, green Hoarding (with clear sections for light filtration) can be noted to left of photo, arrow notes white marker in location of proposed realignment of Hoarding.
