# Arboricultural Impact Assessment

Westconnex New M5  
Euston Road  
ALEXANDRIA NSW 2015

***CDS reference: M5N-ES-RPT-LRW-0046-00***

**Revision 5**

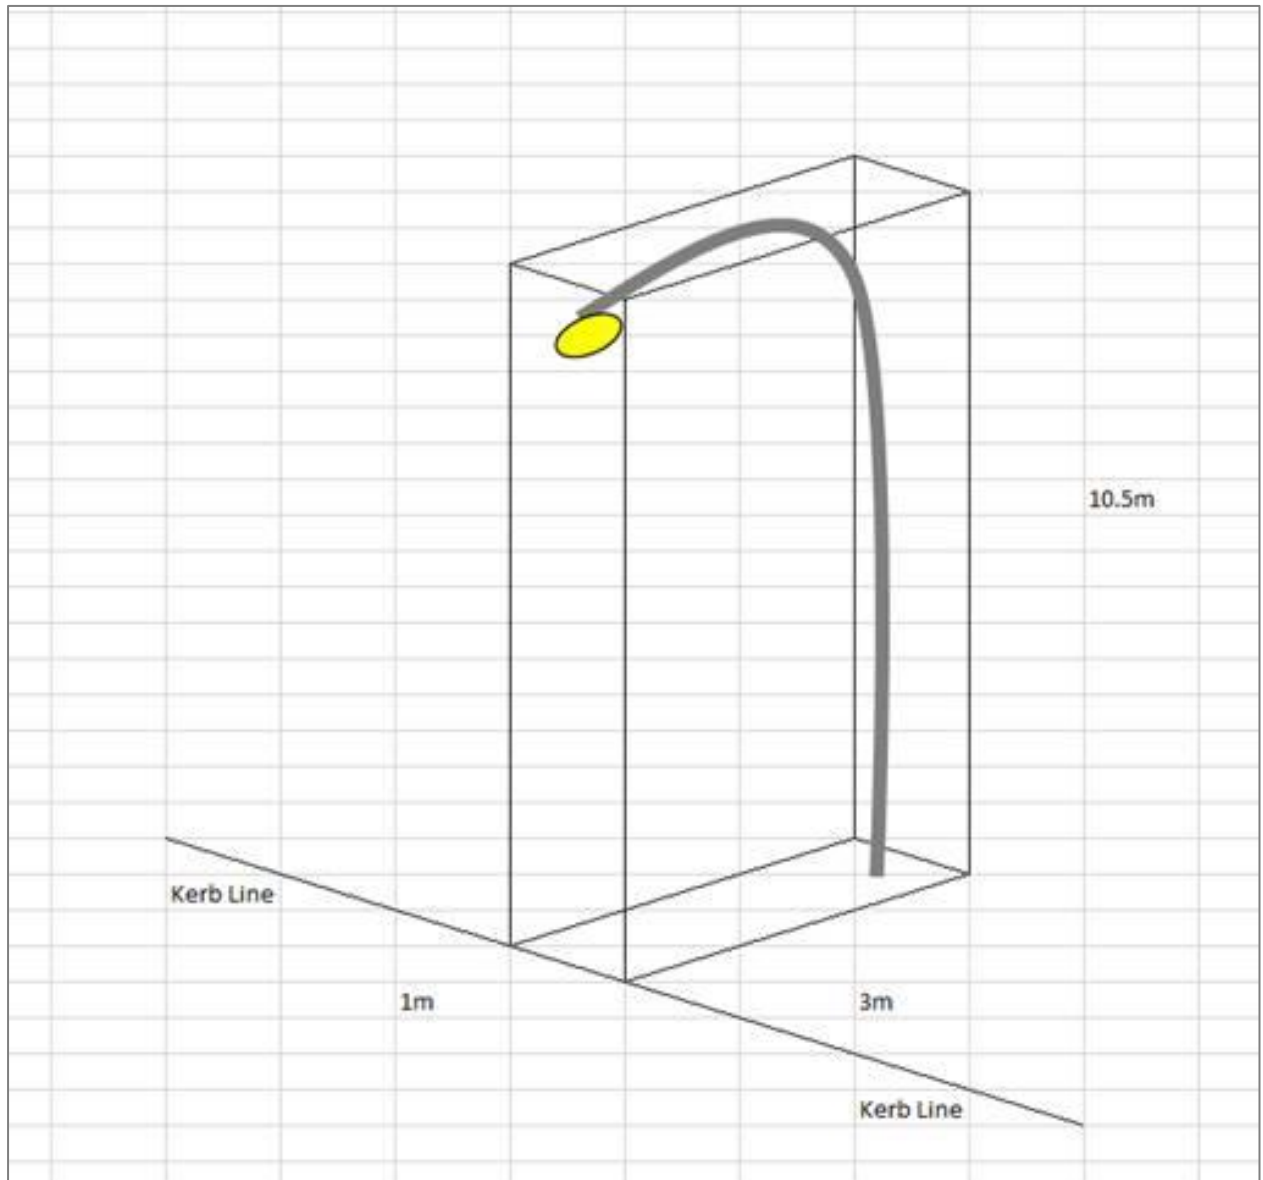
- Street light to be assembled nearby on the ground and luminaire wired on;
- Crane/Excavator to attach the sling and lift the pole facing front on to the kerb;
- Light pole lowered into place and fastened to rag bolt assembly;
- The overall 'zone of influence' is 1m wide x 3m long/deep x 10.5m high (see Appendix B for visual representation).

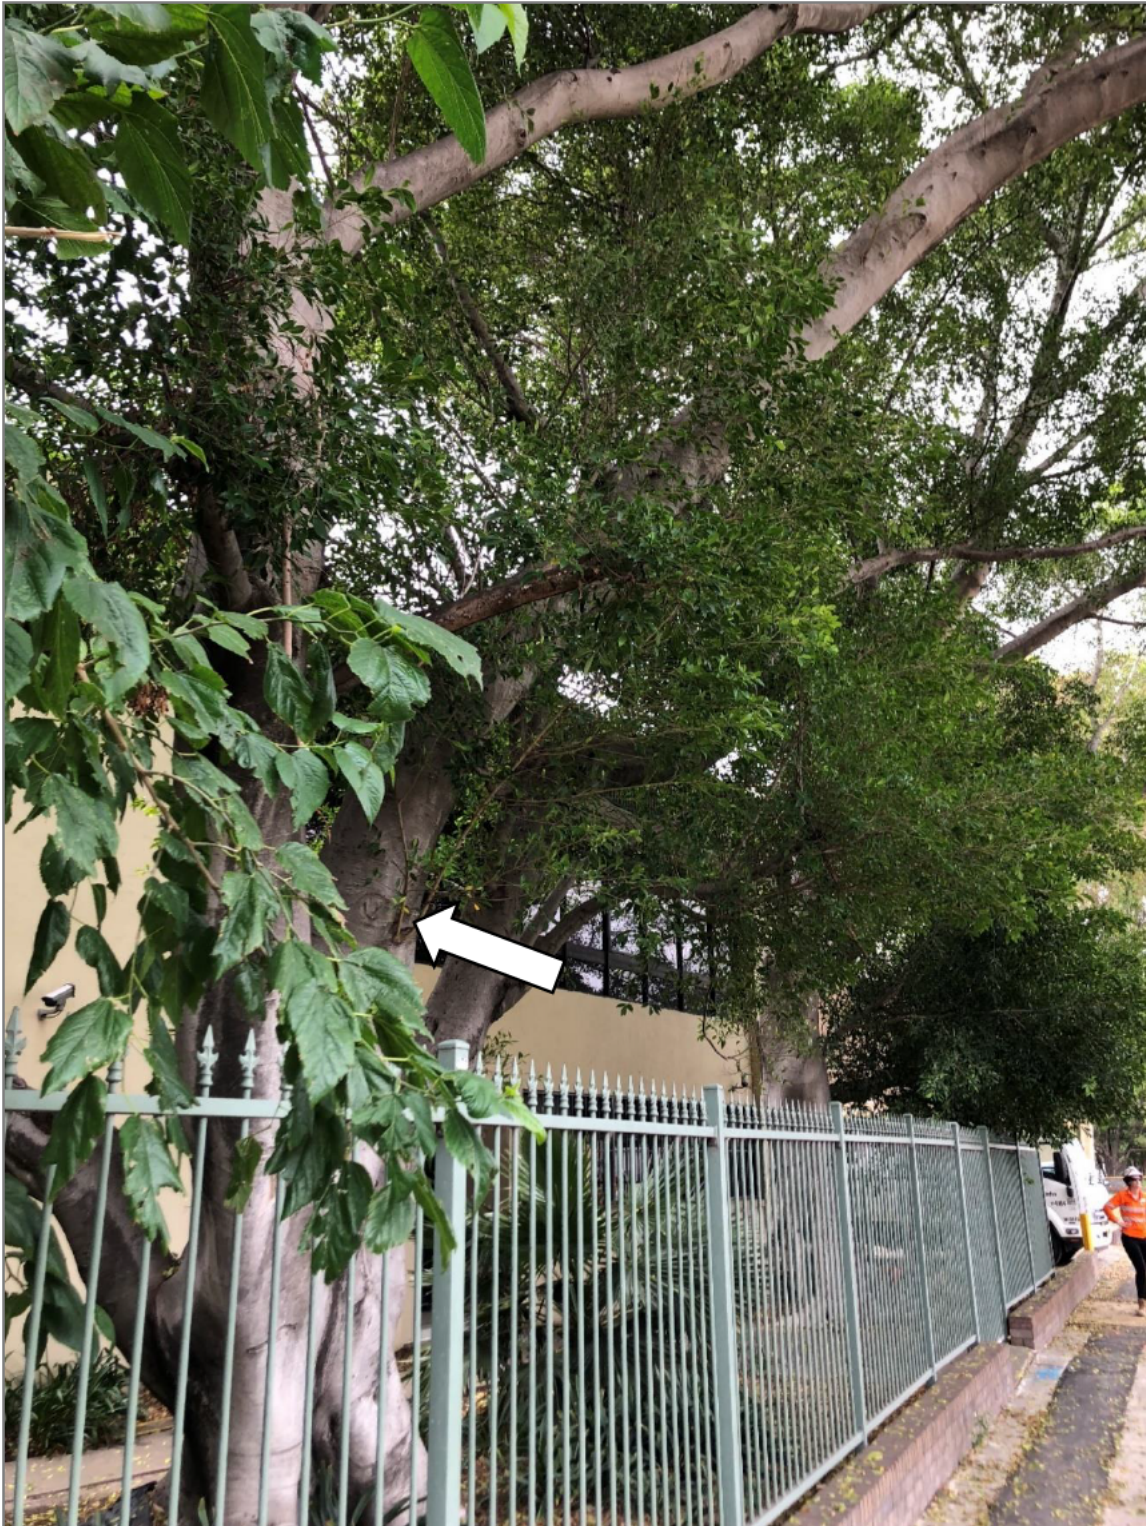
**Plate 1** – Tree A1 49 - Hills Weeping Fig – Arrow notes stem that may require removal to accommodate light pole installation/positioning. It is strongly recommended removal of this entire stem is avoided and only smaller lateral branches removed.

#### 3.2.1 Tree A1 49 – Hills Weeping Fig

- Pruning as described under Clause 7.3.2 – Reduction prune by removing branches to internal lateral branches or stems. Potentially one (1) of the three (3) stems to the north/west may require removal right back to the stem junction, all effort is to be made to avoid this stem removal and to remove only lateral, scaffold limbs. However, this will be best judged by the climber (minimum AQF level 3) once in the tree.
- A maximum 35% of the total live canopy is to be removed.
- All pruned branches are to be mulched onsite and be beneficially reused.

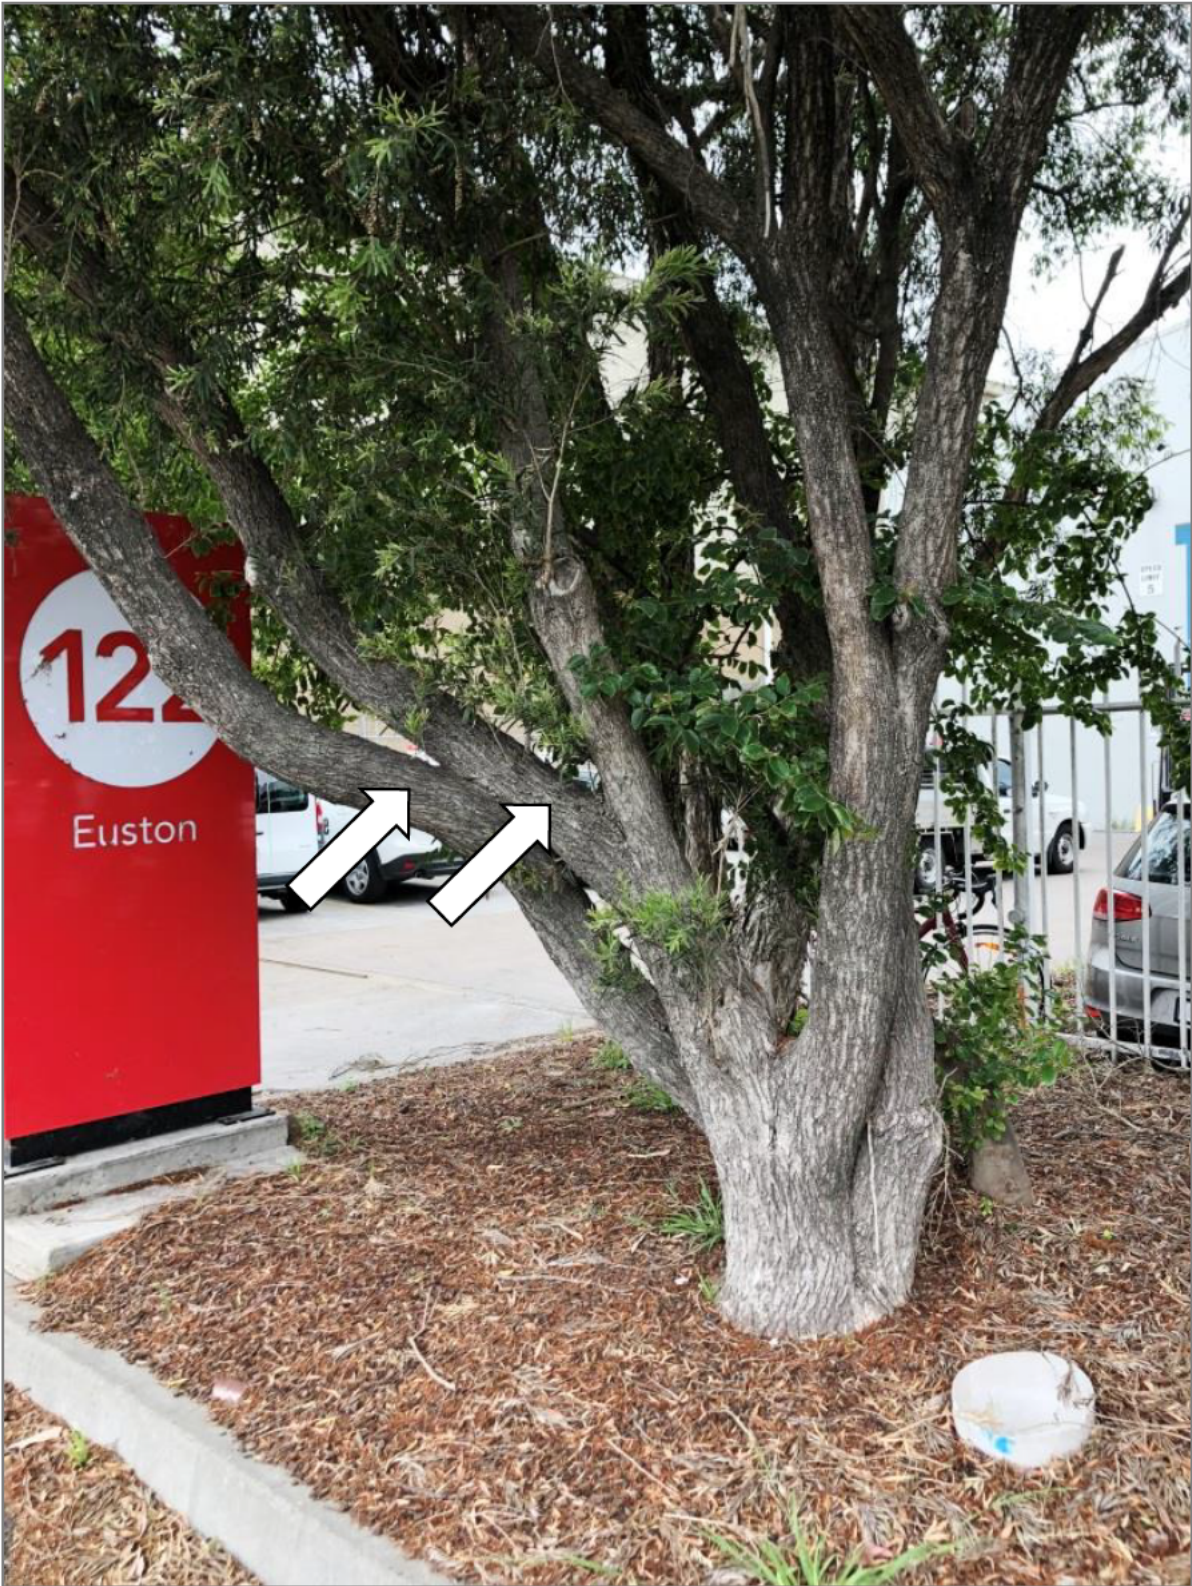
**Plate 2** – A3 122 – Weeping Bottlebrush. Arrows note large low squeezing scaffold branches that require removal. A3 126 can be noted behind A3 122.

### 3.2.9 Tree A3 122 – Weeping Bottlebrush

- Pruning as described under Clause 7.3.2 – Reduction prune by removing branches to internal lateral branches or stems. Two (2) low squeezing limbs (150mm & 160mm Ø) to the north-west are to be removed.
- A maximum 35% of the total live canopy is to be removed.
- A representative of WIRES is to be present during pruning works as a bird’s nest (unknown species) is located within this tree. Any direction provided by the WIRES representative is to be strictly followed.
- All pruned branches are to be mulched onsite and be beneficially reused.

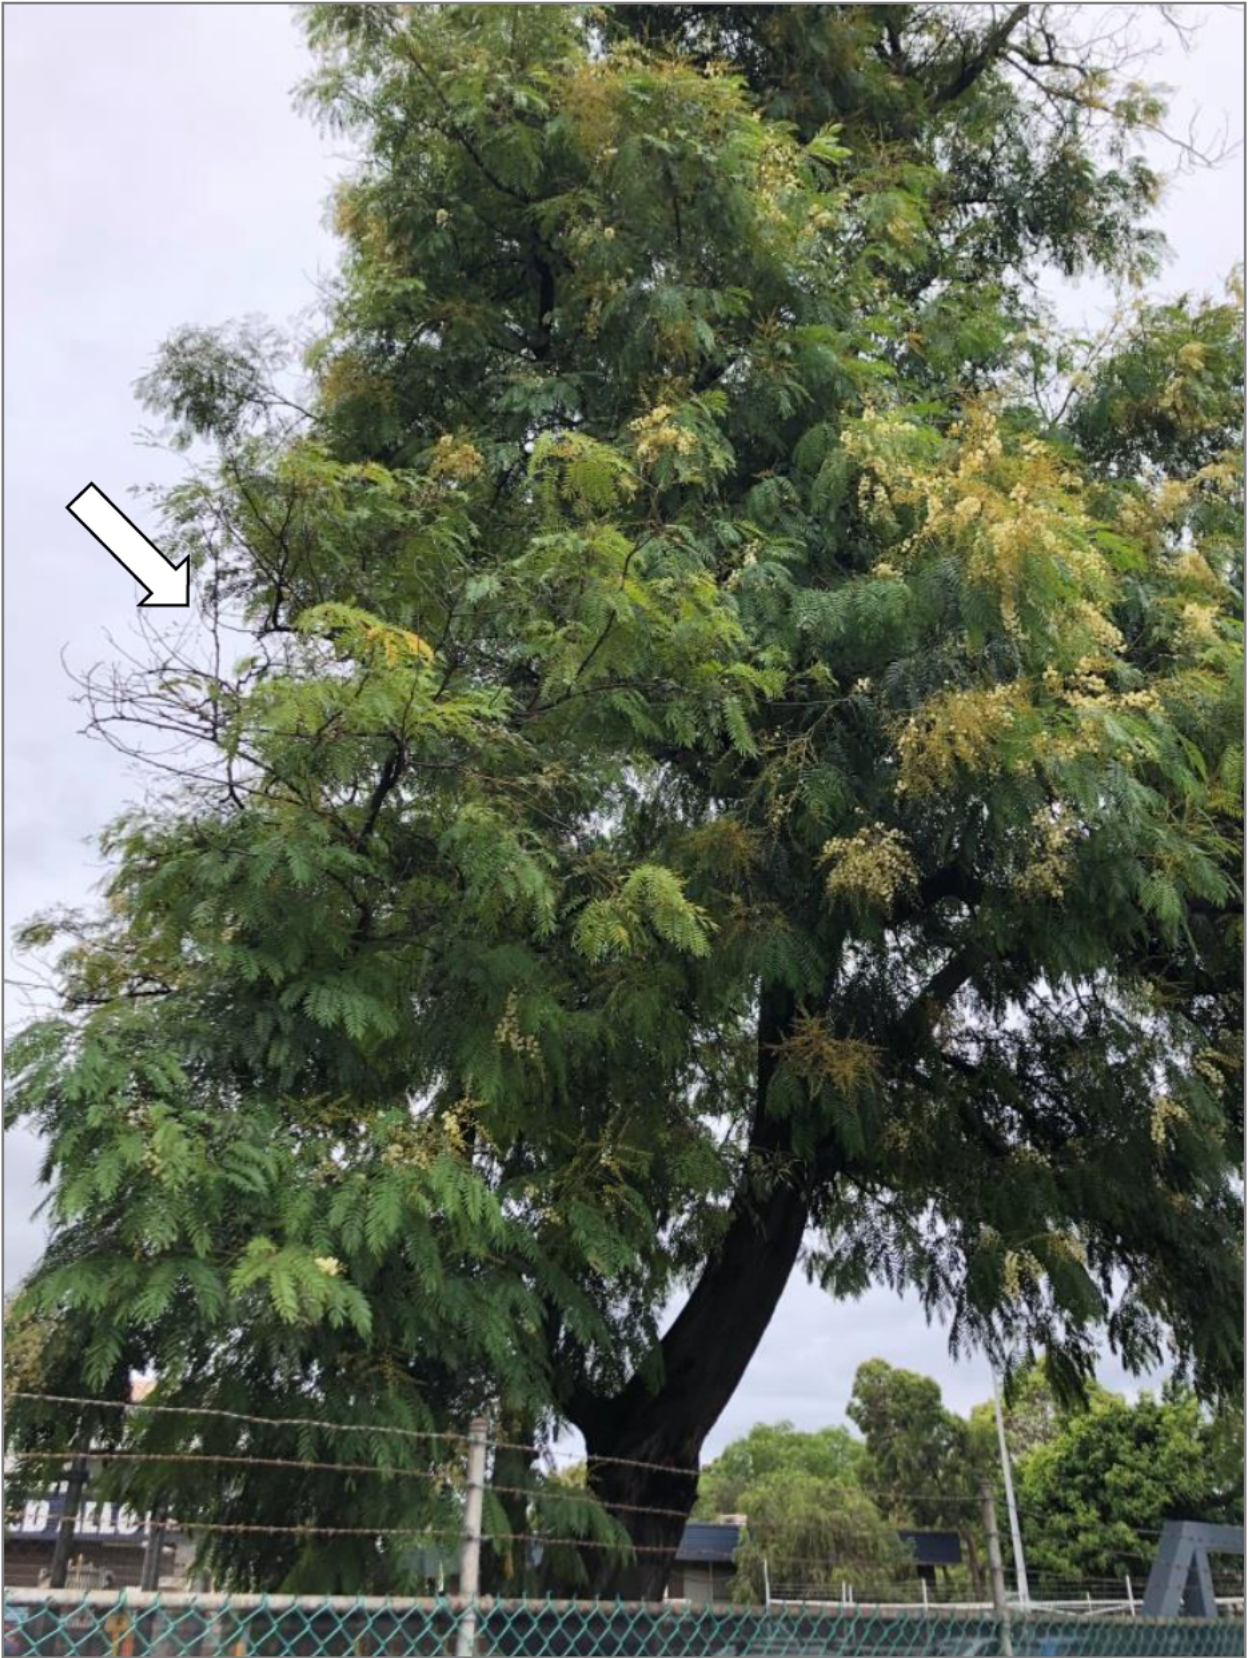
Plate 3 – A2 97 – Cedar Wattle – Minor pruning is only required for light installation.

### **3.2.3**                    **Tree A2 97 – Cedar Wattle**

- Pruning as described under Clause 7.3.2 – Reduction prune by removing branches to internal lateral branches or stems. Several small diameter limbs to the north/west side of canopy to be removed.
- A maximum 10% of the total live canopy is to be removed.
- All pruned branches are to be mulched onsite and be beneficially reused.

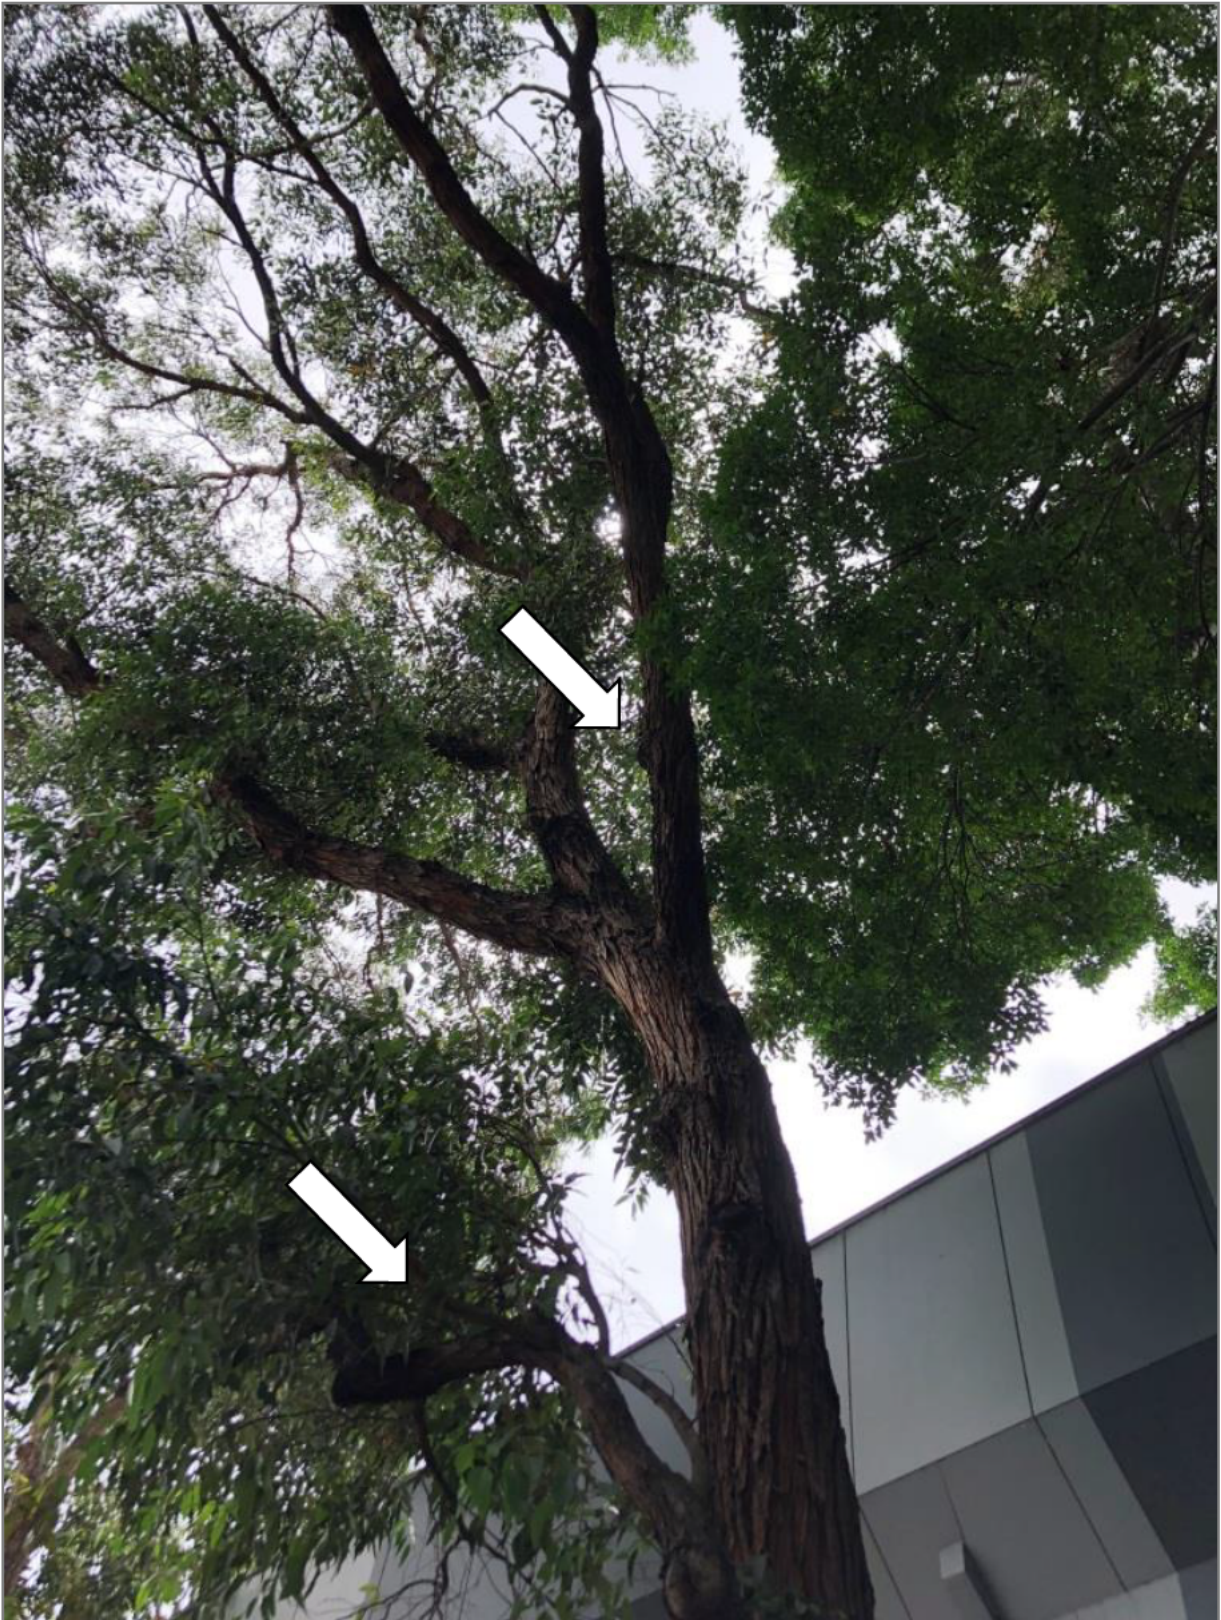
Plate 4 – A1 177 – Swamp Mahogany – Arrows note limbs requiring removal to accommodate light pole installation/positioning.

### **3.2.2**                    **Tree A1 177 – Swamp Mahogany**

- Pruning as described under Clause 7.3.2 – Reduction prune by removing branches to internal lateral branches or stems. One (1) low limb (stub with epicormics growth only) to the north-west and one (1) 180mm Ø scaffold branch to the south of the canopy is to be removed.
- A maximum 25%-30% of the total live canopy is to be removed.
- All pruned branches are to be mulched onsite and be beneficially reused.

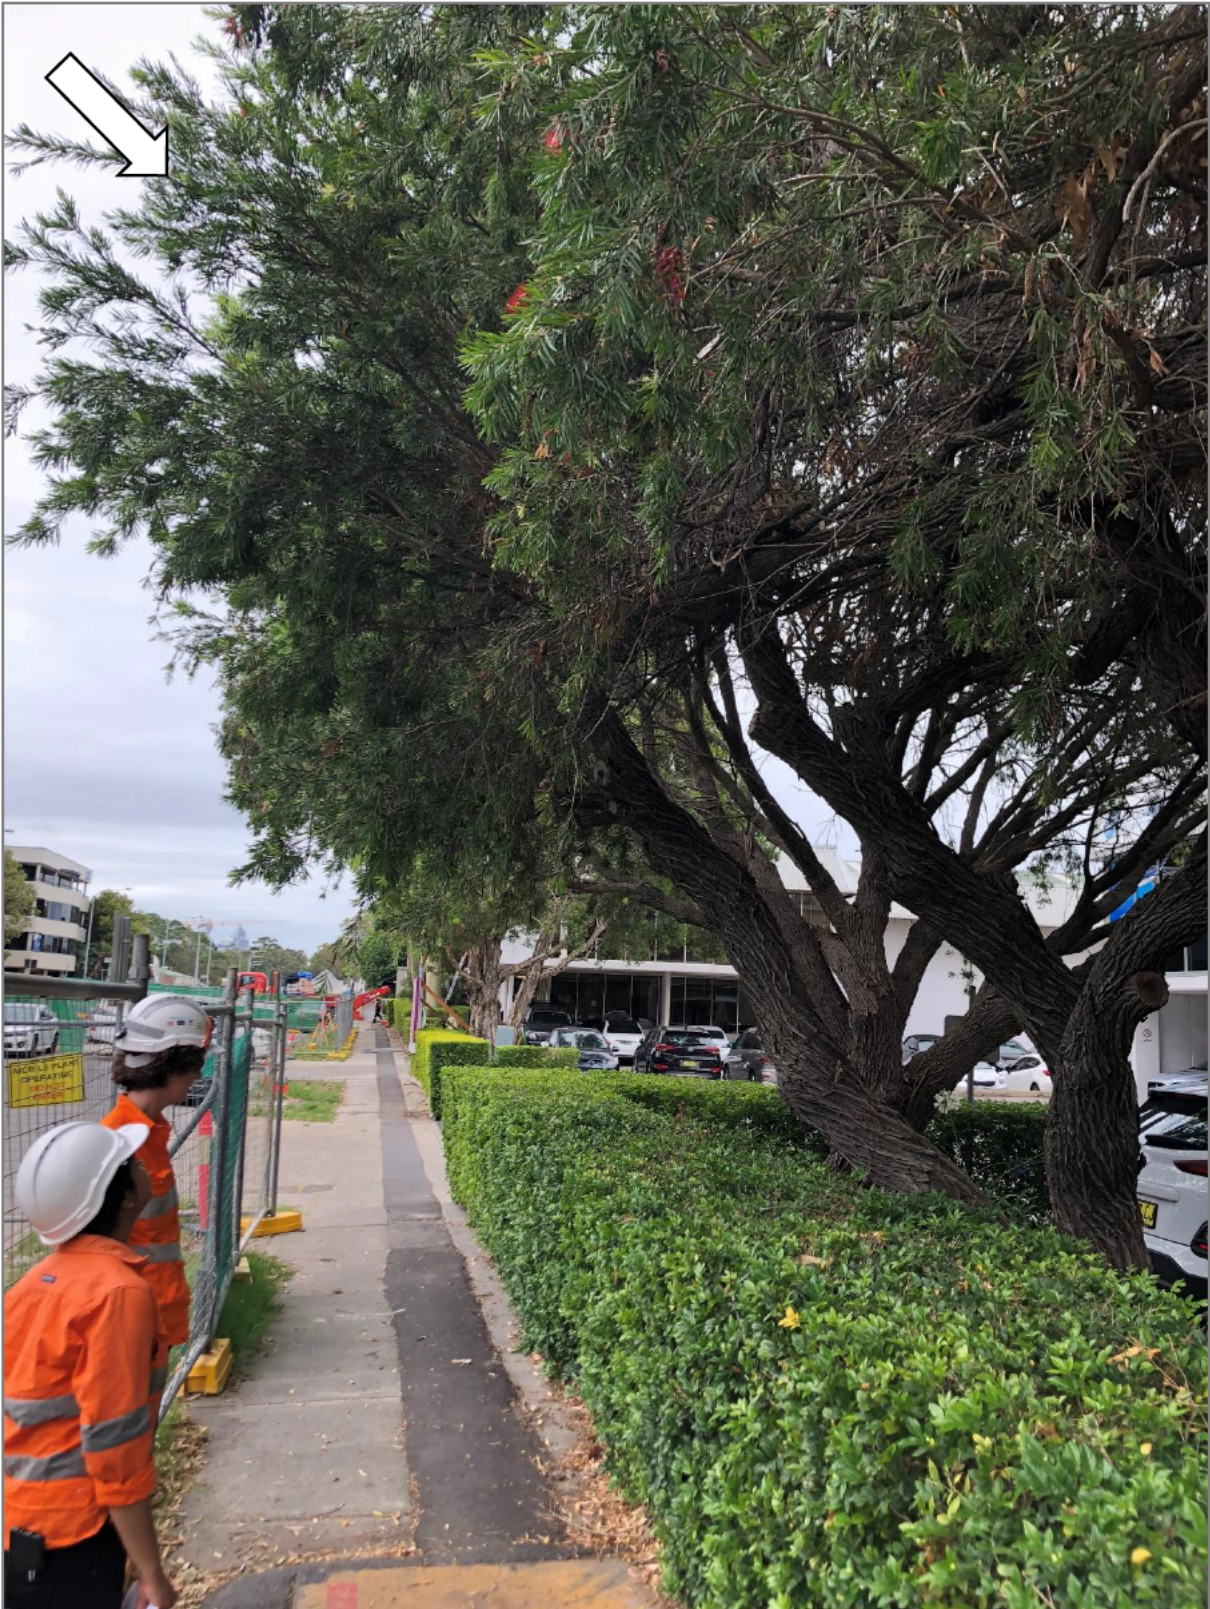
Plate 5 – A2 147 & A2 151s – Weeping Bottlebrush – Arrow note limbs requiring removal to accommodate light pole installation/positioning.

### **3.2.4**                    **Tree A2 147 – Weeping Bottlebrush**

- Pruning as described under Clause 7.3.2 – Reduction prune by removing branches to internal lateral branches or stems on the north/western side of the canopy. One (1) 100mm Ø and several 60-80mm Ø branches to be removed.
- A maximum 20% of the total live canopy is to be removed.
- All pruned branches are to be mulched onsite and be beneficially reused.

### **3.2.5**                    **Tree A2 151s – Weeping Bottlebrush**

- Pruning as described under Clause 7.3.2 – Reduction prune by removing branches to internal lateral branches or stems on the north/western side of the canopy. A maximum branch diameter of 60mm is to be removed.
- A maximum 10% of the total live canopy is to be removed.
- All pruned branches are to be mulched onsite and be beneficially reused.

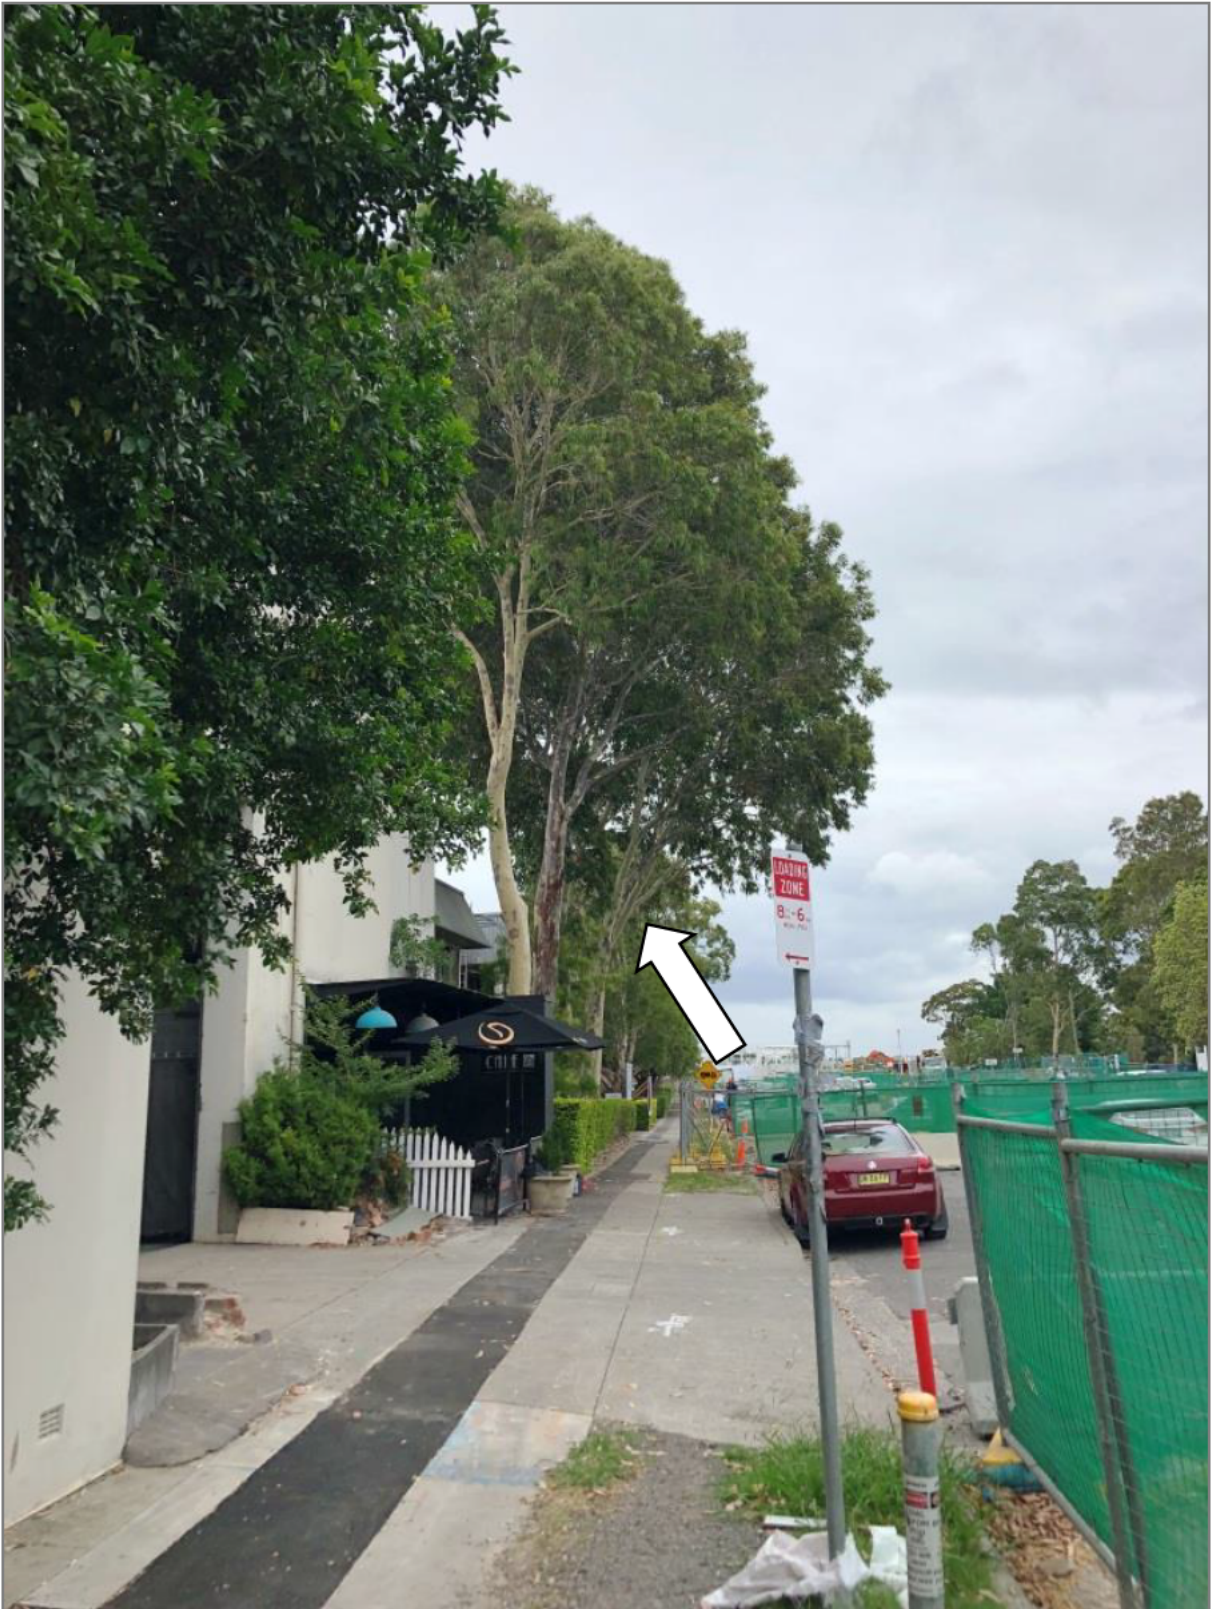
**Plate 6** – A2 166 – Lemon Scented Gum – Arrow notes tree and limbs requiring removal to accommodate light pole installation/positioning.

### **3.2.6**                    **Tree A2 166 – Lemon Scented Gum**

- Pruning as described under Clause 7.3.2 – Reduction prune by removing branches to internal lateral branches or stems. Two (2) to three (3) branches up to a maximum 120mm Ø are to be removed on the north-western side of the canopy.
- A maximum 15% of the total live canopy is to be removed.
- All pruned branches are to be mulched onsite and be beneficially reused.

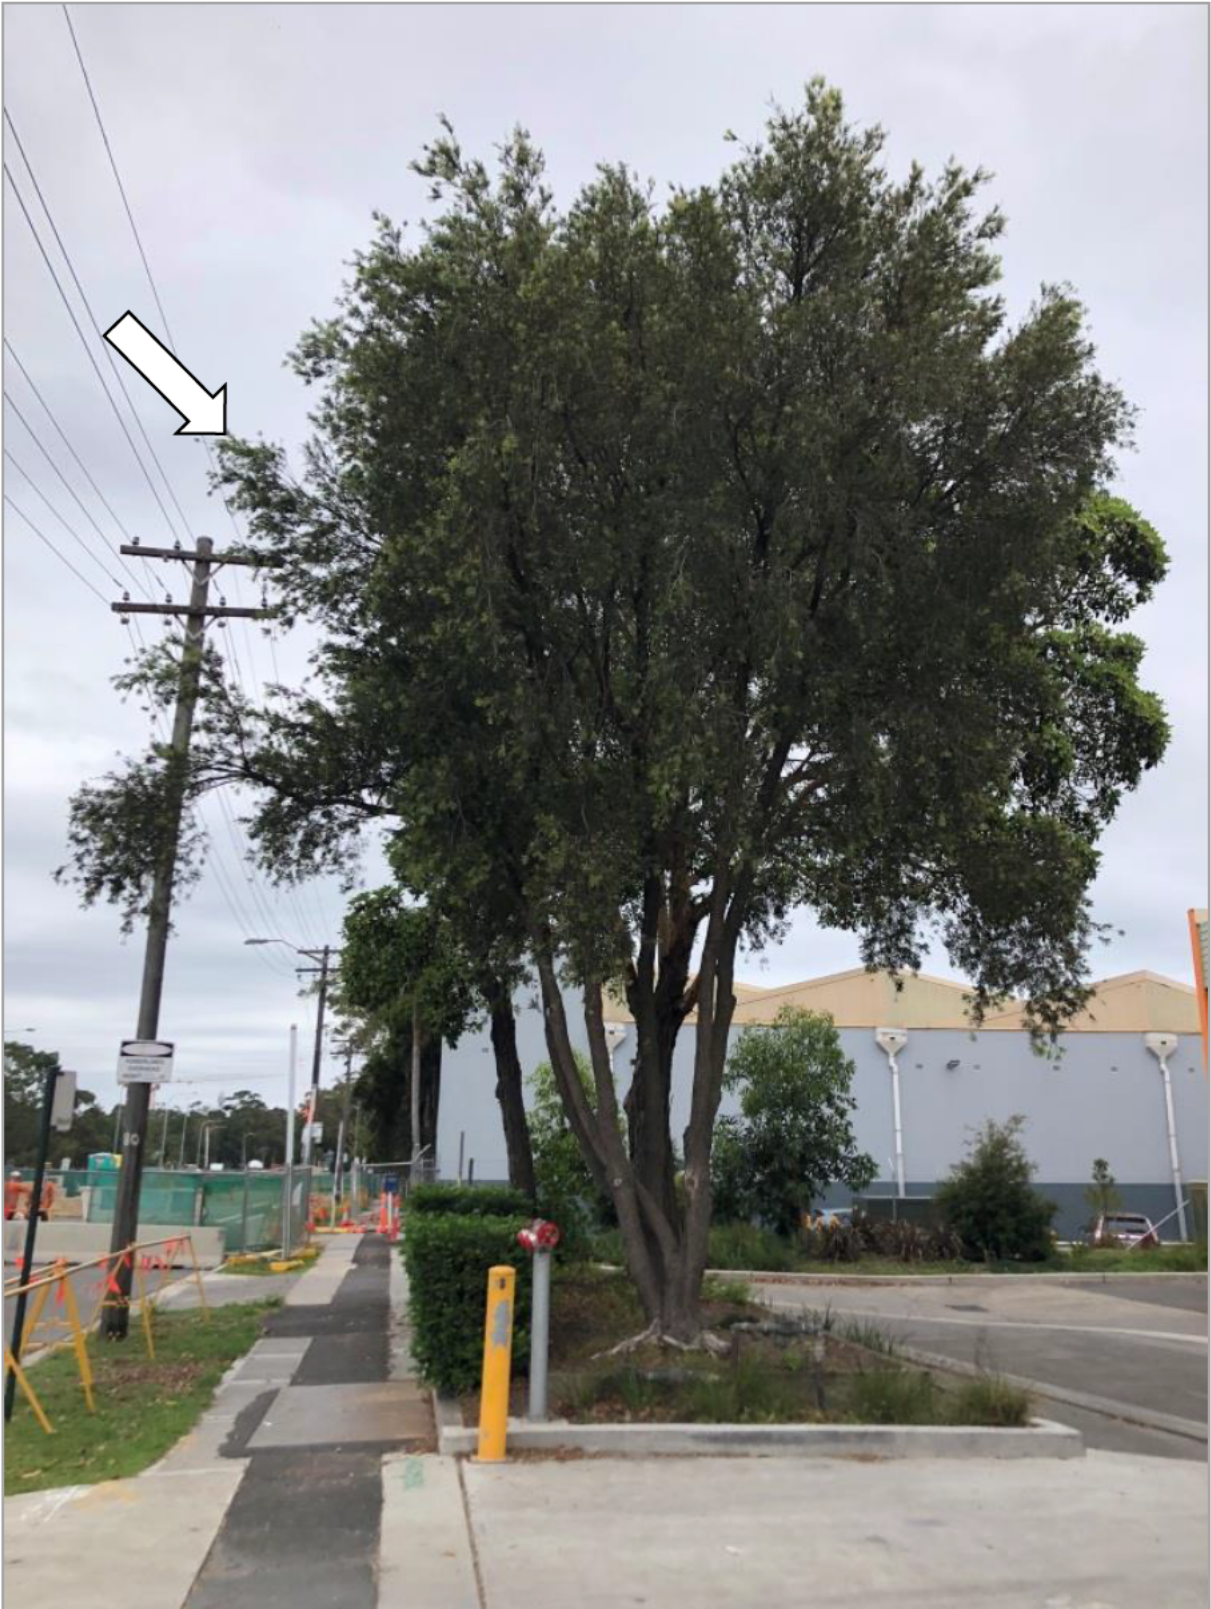
**Plate 7** – A3 29 – Weeping Bottlebrush – Arrow notes limbs requiring removal to accommodate light pole installation/positioning.

### **3.2.7**                    **Tree A3 29 – Weeping Bottlebrush**

- Pruning as described under Clause 7.3.2 – Reduction prune by removing branches to internal lateral branches or stems. One (1) limb to the north-west 80mm Ø and several up to a maximum 40mm Ø are to be removed.
- A maximum 10% of the total live canopy is to be removed.
